INVESTIGATION OF JULY 1, 1992 FAILURE OF A CRAWLER CRANE IN BOSTON, MASSACHUSETTS

U.S. DEPARTMENT OF LABOR
OCCUPATIONAL SAFETY AND HEALTH ADMINISTRATION
December 1992

This report was written
by
David T. Lashgari, P.E.

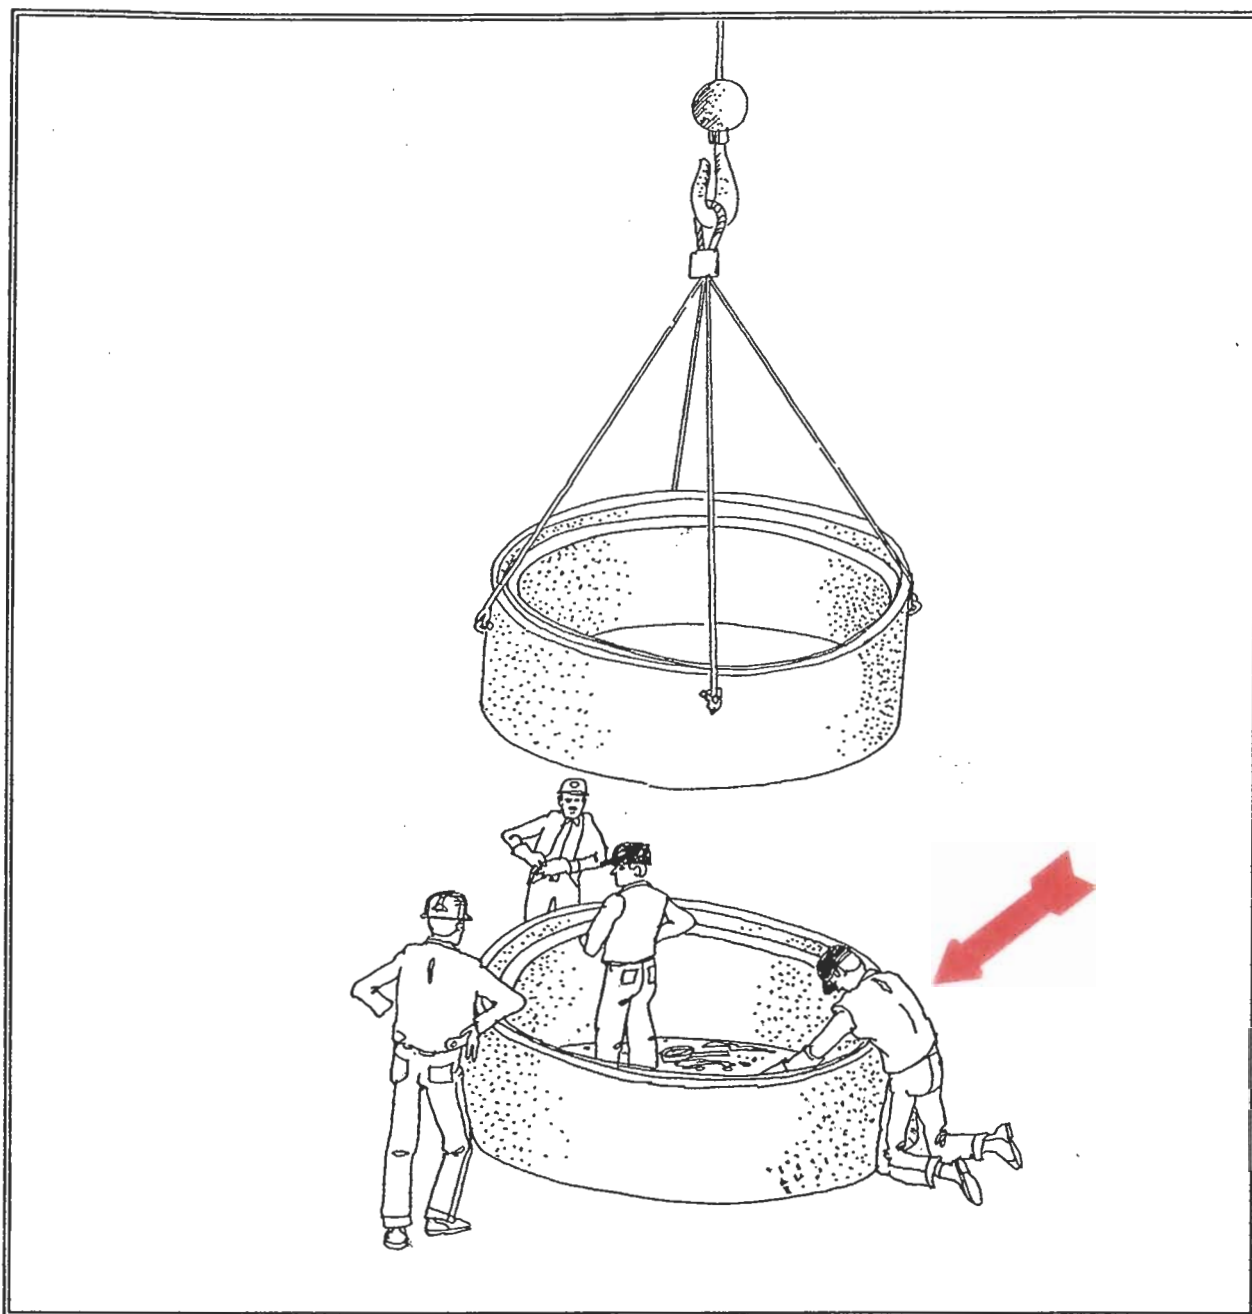
Figure 1.1 The concrete section was lifted and held at about four feet above the victim and three other workers.

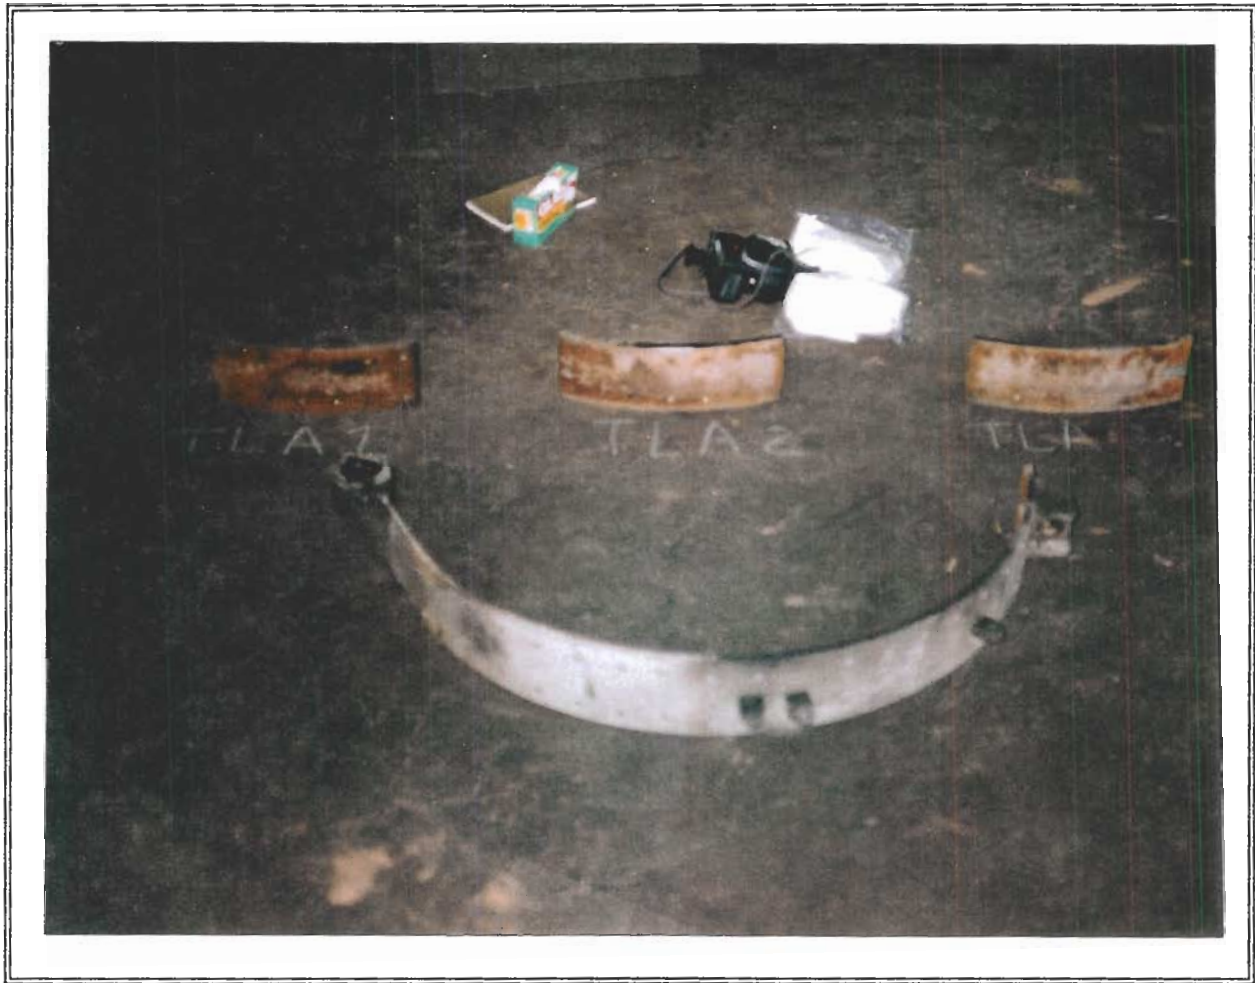
Figure 2.1 Disassembled top left (TL) friction brake band of the main hoist drum along with its three brake linings.

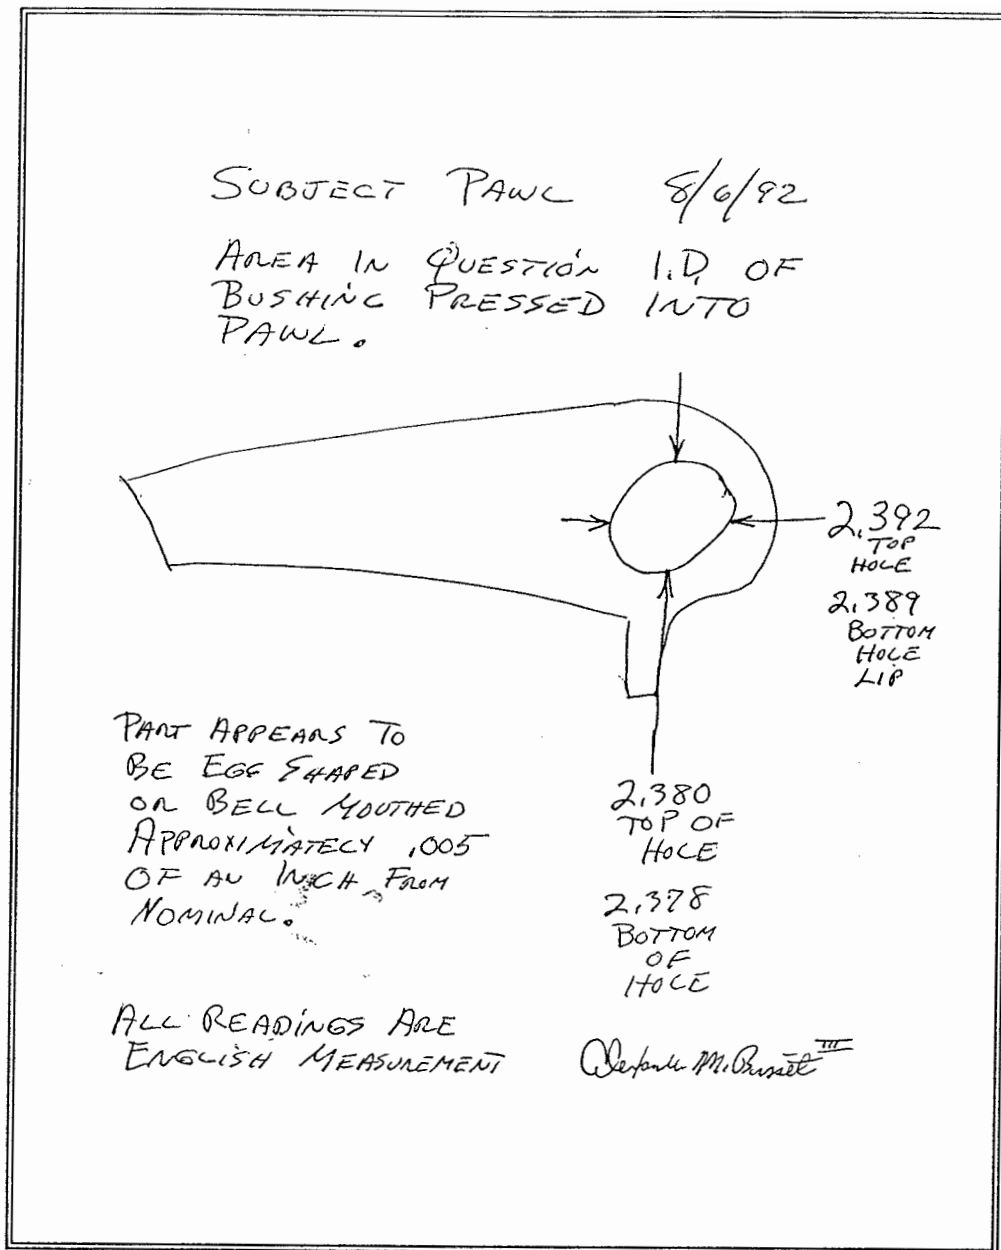
Figure 2.2 OSHA measured the geometric dimensions of the pawl and compared these measurements to those specified by the manufacturer's design specifications.

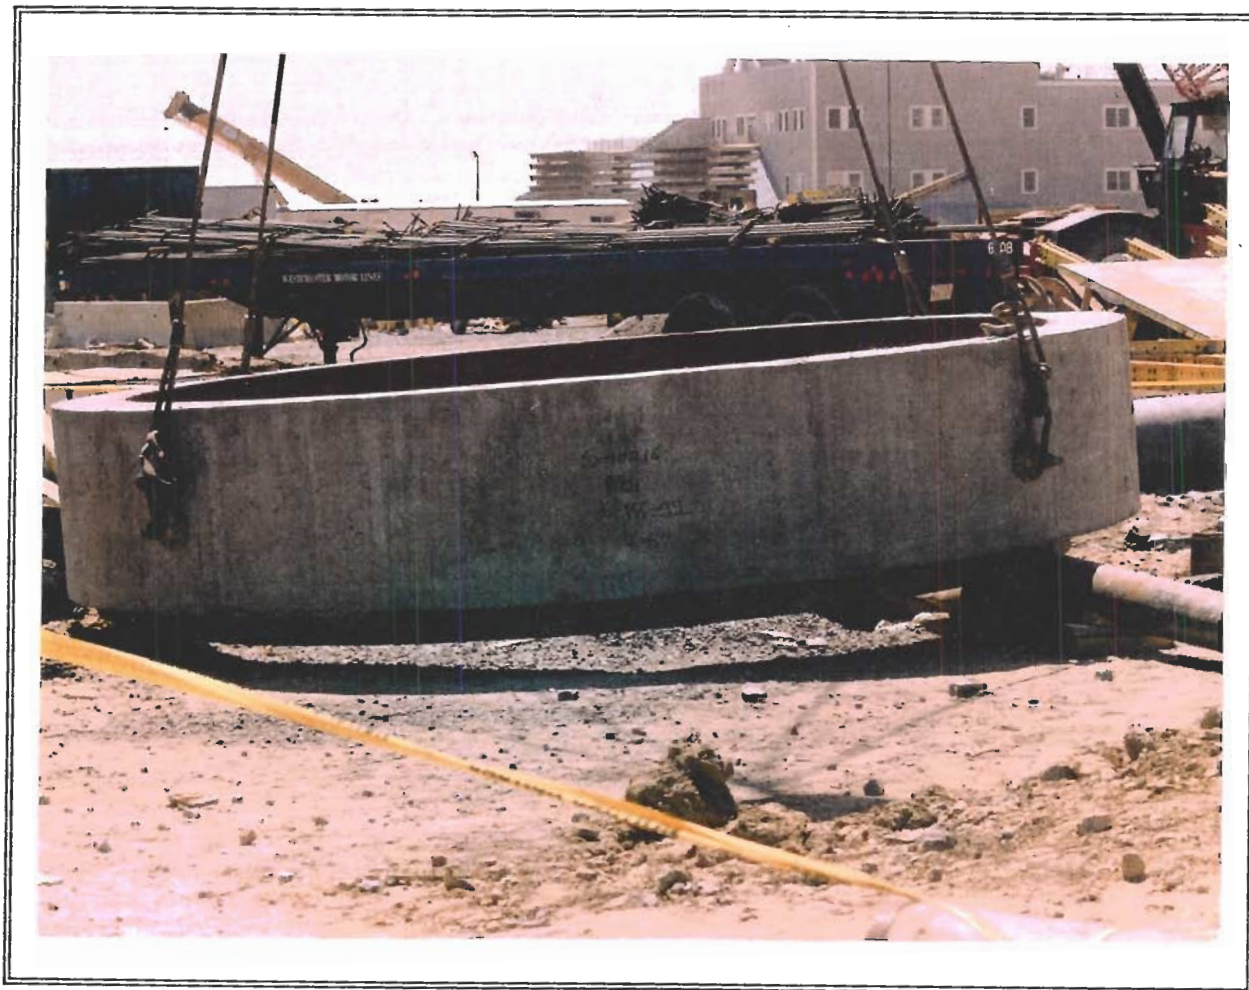
Figure 2.3 OSHA conducted post-accident functional tests of the crane's primary and secondary brake systems using the same concrete section which was involved in the accident.

On July 2, 1992, the primary friction braking system of the crane was tested under OSHA supervision. The test was conducted by hoisting the same concrete section that was involved in the accident. Several attempts were made to hold the load by application of the primary friction brake system. Out of a total of five attempts, the primary friction brake system failed to function on three occasions - resulting in sudden release of the load and its fall to the ground, as it had occurred during the accident. On two occasions, the primary brake system functioned and held the load at the desired suspended elevation (ref. exhibit no.s 3 & 4).

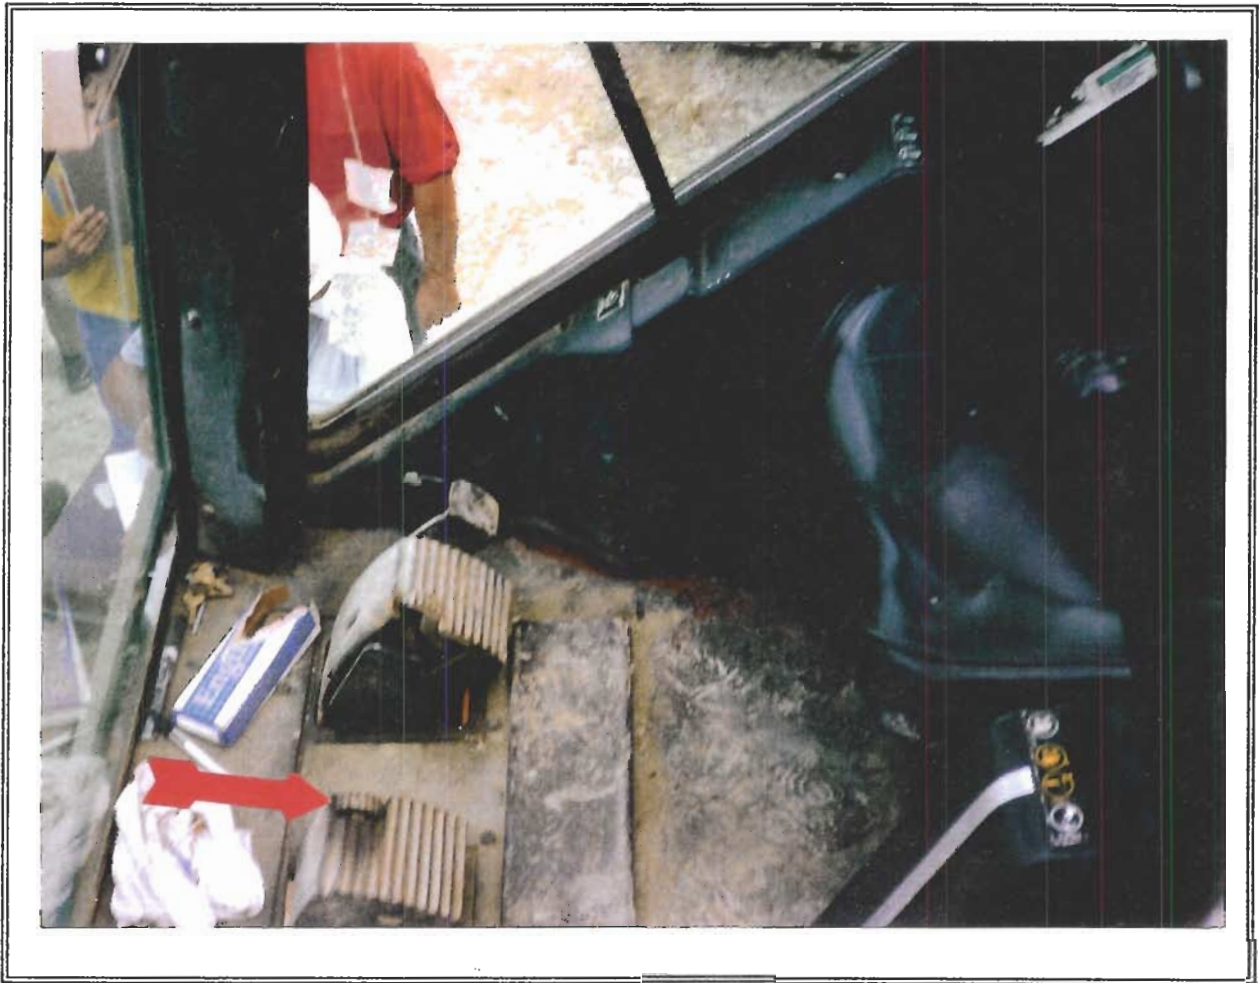
According to eyewitness statements, the operator had locked the primary brakes by having pressed and locked the latch attached to the foot brake pedal (ref. fig. 3.3). Then, the operator proceeded to activate the (secondary) spring-applied, hydraulically-released brake system. In order to engage the secondary brake system - consisting of a pawl engaging the sloping teeth of the front drum - the operator slightly released the friction brake so the tip of the pawl could position itself on the teeth of the front drum (ref. fig. 3.4). Once having assumed that he had engaged the secondary mechanical brake, the operator proceeded to lock the friction brake by pressing his foot on the pedal. It is at this instant that according to eyewitness statements, the load slid through and struck the victim (ref. fig. 3.5). However, moments prior to the sudden fall of the load, three of the workers had finished application of the sealant material and had stood upright while the victim was still in the kneeling position - engaged in application of the sealant material to the surface of the bottom concrete section (ref. fig. 3.6). The falling section struck the victim and caused him fatal injuries.

Figure 3.3 The friction brake foot pedal. The brake locking latch is shown in top left corner of the pedal.

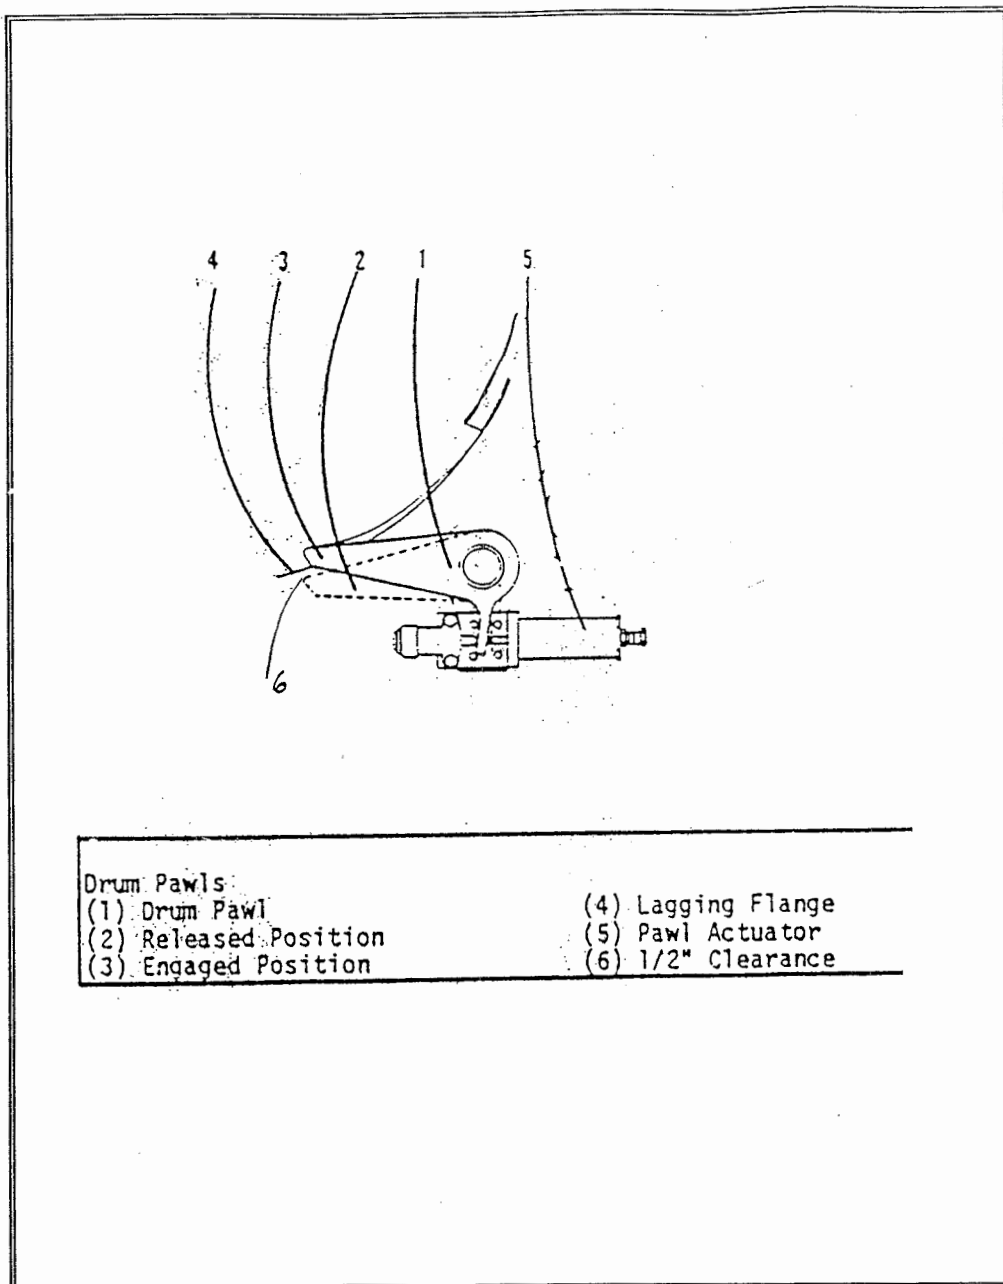
Figure 3.4 The main hoist drum shaft has a pawl assembly which rides on teeth cut in the lagging flange. When the pawl is engaged, the rope can't wind off the drum.

- (2). The secondary braking system failed to function properly during the accident. The main hoist drum shaft has a pawl assembly which rides on teeth cut in the lagging flange. As per the manufacturer's design specifications, when the pawl is engaged, the rope can't wind off the drum because the pawl holds the drum against rotation. The pawl is spring-applied and hydraulically-released. The pawl is operated by control knobs on the operator's front instrument panel. OSHA determined that the lateral vacillation of the pawl was excessive to the

extent that it caused the pawl to miss the required engagement surface with the teeth cut in the lagging flange. During disassembly of the pawl mechanism, six 12-gauge (0.1046 in.) spacer washers were found to be providing the only lateral restraint (three spacer washers on each side) of the pawl against vacillation. According to measurements by OSHA, the spacer washers (3 on each side of the pawl) were the only lateral restraint for the pawl. Two sets of 1.875" calculations were performed. The first set was based on the distance between bosses (frame components) as determined from the manufacturer's design drawings. The second set of calculations was based on the distance between bosses (frame components) of 1.975" as measured by OSHA after the accident. Based on the results of calculations performed, it was determined that if there had been no washers, the amount of vacillation at the tip of the pawl would be approximately 1.431" and it would not contact the flange. However, in the first set of calculations, it was determined that because of the presence of 3 washers on each side of the pawl the vacillation at the tip of the pawl was reduced to approximately 7/8".

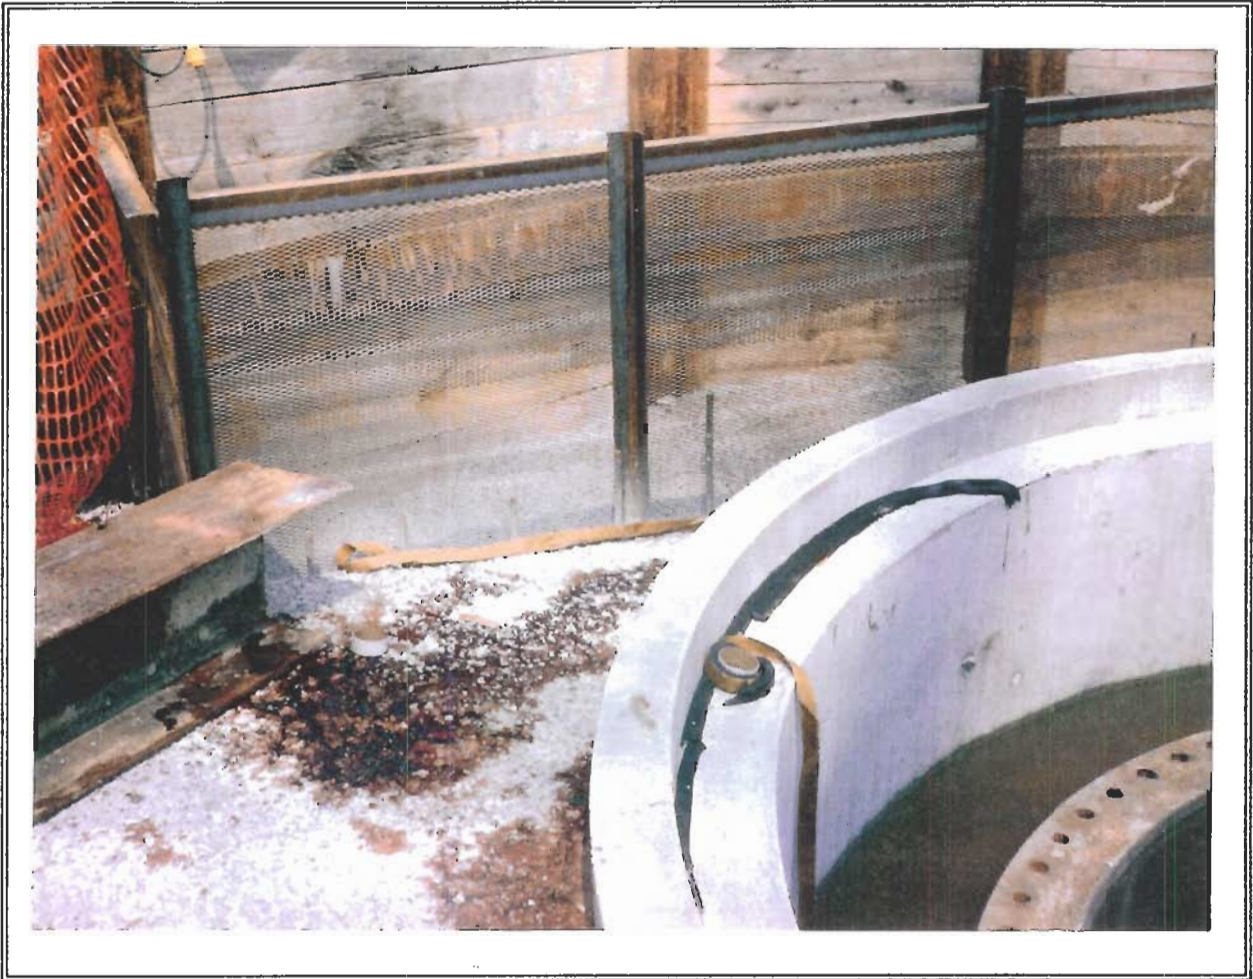
Figure 3.5 The load slid through the brakes and struck the victim. The victim's tape of sealant material and the bottom concrete section are shown above.

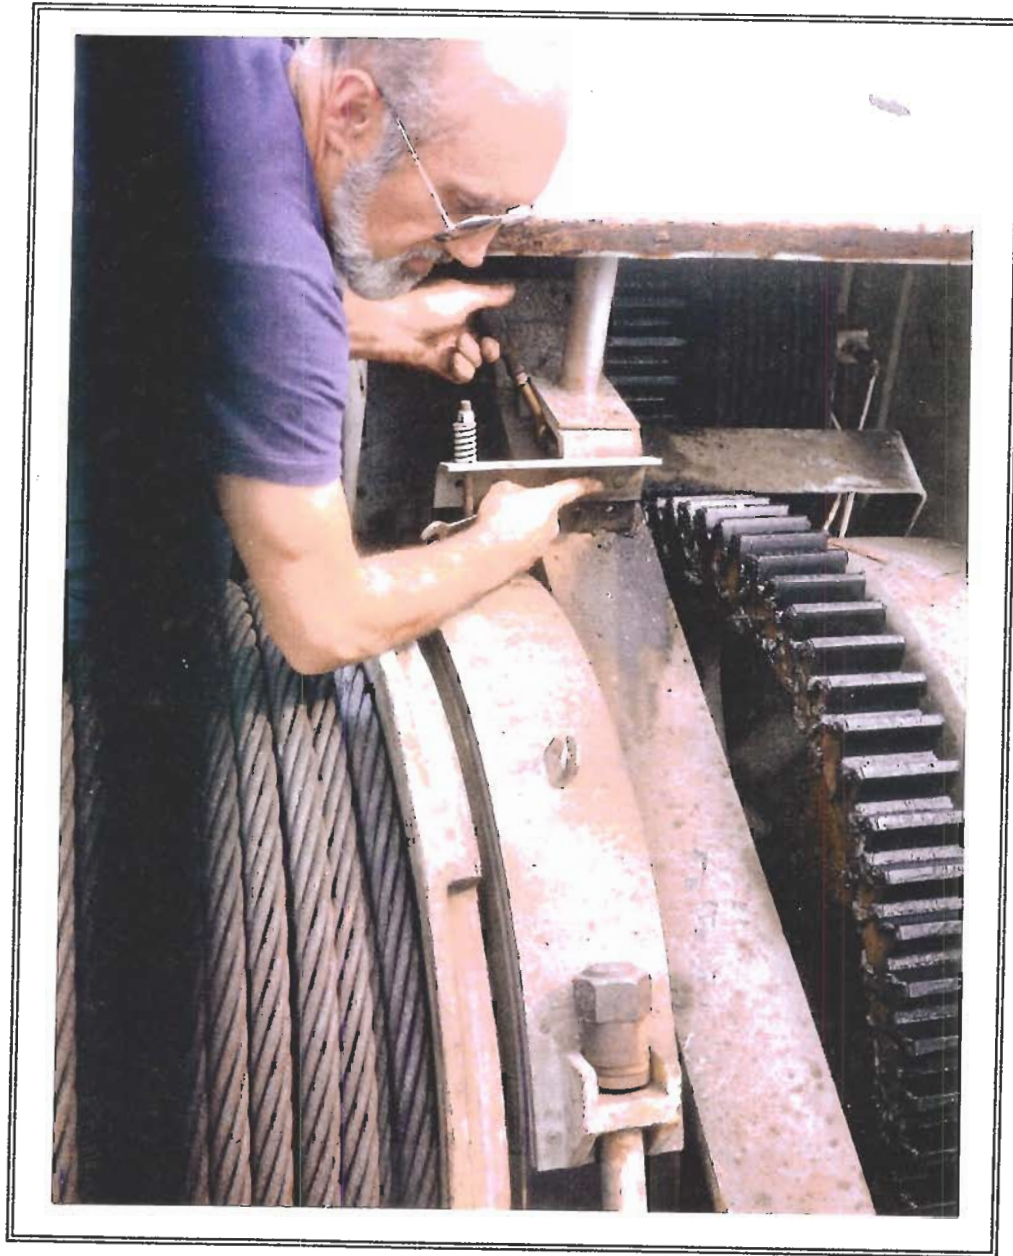
Figure 5.1 The brake bands of the main hoist drum were disassembled so the condition of the brake drums and linings could be further investigated.

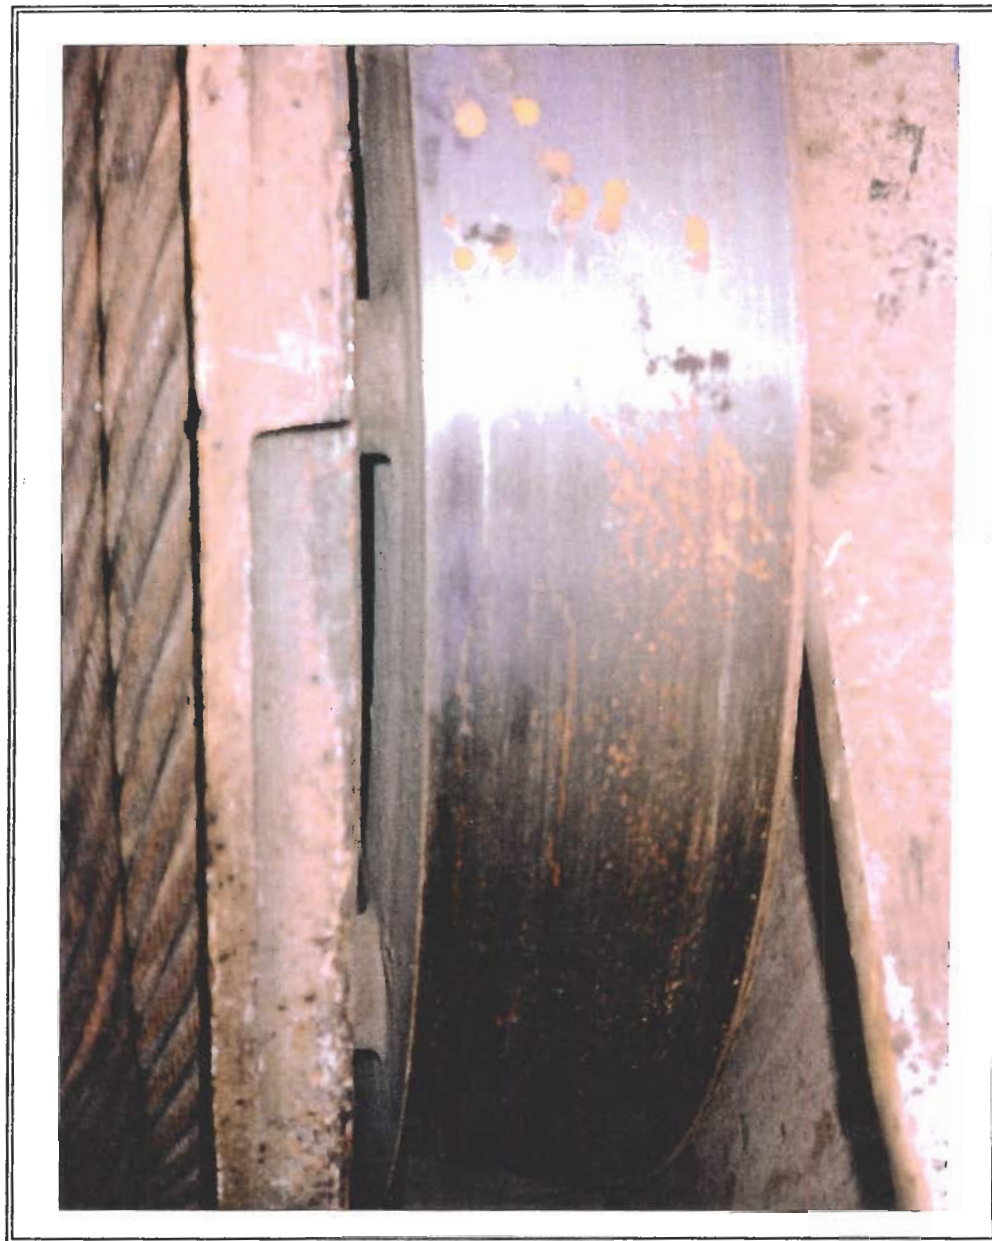
Figure 5.2 The surface of the brake drums contained patches of rust and scale.

- (1). The failure of the primary braking system was due to (a) lack of adequate periodic adjustments of the brakes and (b) development and accumulation of rust and other undesirable particulate matter between the friction surfaces of the brake drum and linings. According to eyewitness statements taken by OSHA under oath, the specific drum used on the day of the accident had not been utilized for about a month. OSHA discovered a significant number of rust patches on the metallic surface of the brake drums when it disassembled the machine's friction brake system and examined the condition of both the brake drums and the brake linings. In addition, significant quantities of rust and other undesirable particulate matter were collected from the space between the surfaces of the brake drums and linings. Furthermore, material evidence obtained by OSHA - a daily journal kept by the oiler of the crane - (ref. chapter 5) demonstrates the existence of a pattern of conduct which can be reasonably evaluated as not attentive to the crane's periodic maintenance requirements. In fact according to the manufacturer's Operator's Manual, the adjustment of brakes must be part of a regular weekly maintenance program (ref. Appendix B). No records were submitted to OSHA which indicated compliance with such a maintenance requirement by the users of the crane.

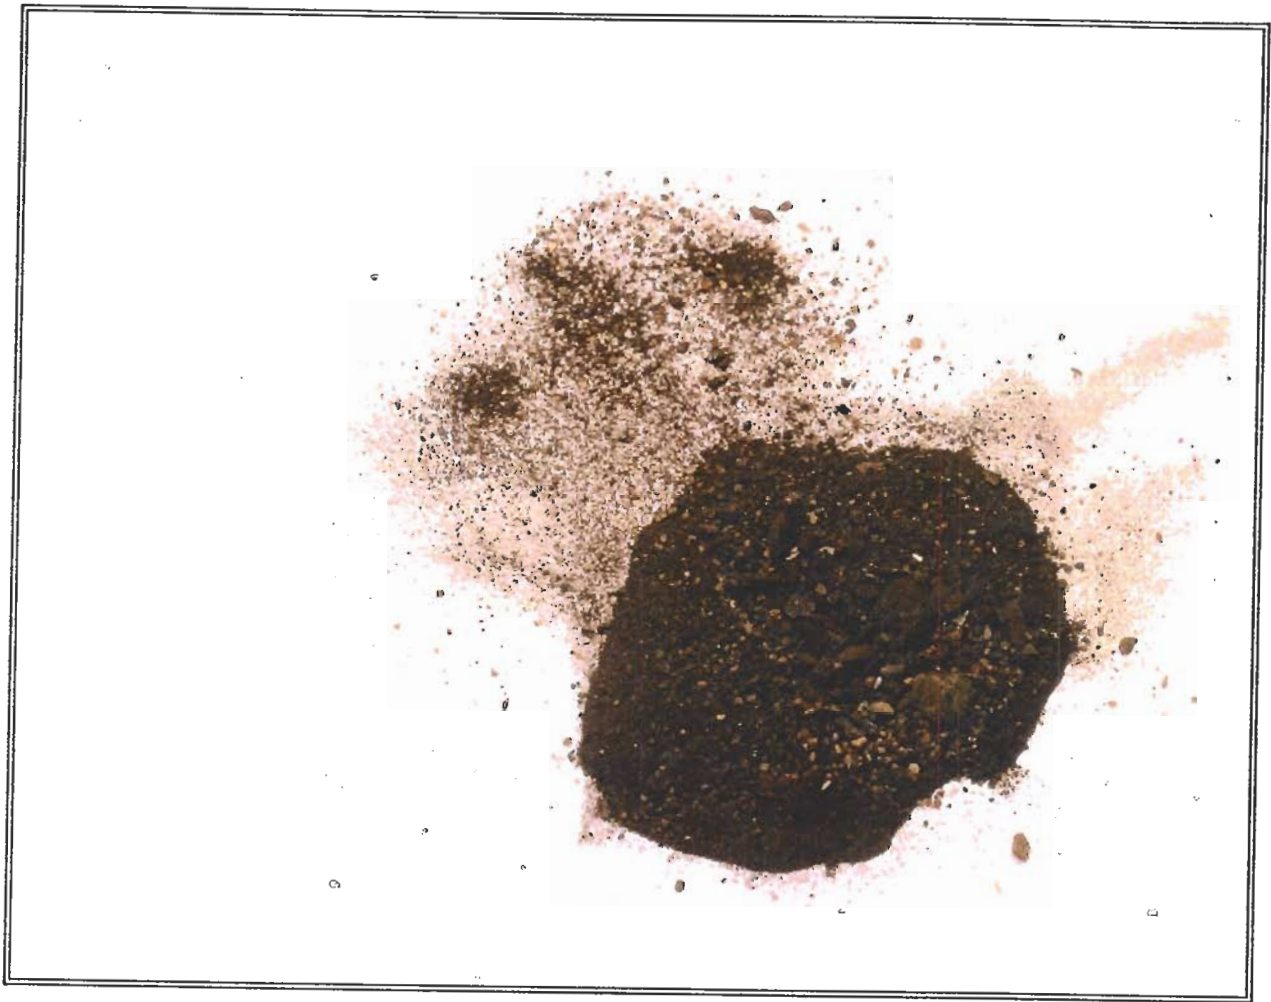
friction brake system involving the same load that was used in earlier tests. The friction brake system functioned properly during all these subsequent tests. Based on this observation, OSHA proceeded to have the friction brake system disassembled so the condition of the brake drums and linings could be further investigated (ref. fig. 5.1). The surface of the brake drums were observed to contain patches of rust (ref. fig. 5.2) and significant quantity of rust, scale and other particulate matter which were collected from the interior surfaces of the disassembled brake linings (ref. fig. 5.3).

Figure 5.3 OSHA collected significant quantity of rust, scale and other particulate matter from the interior surfaces of the disassembled brake linings.

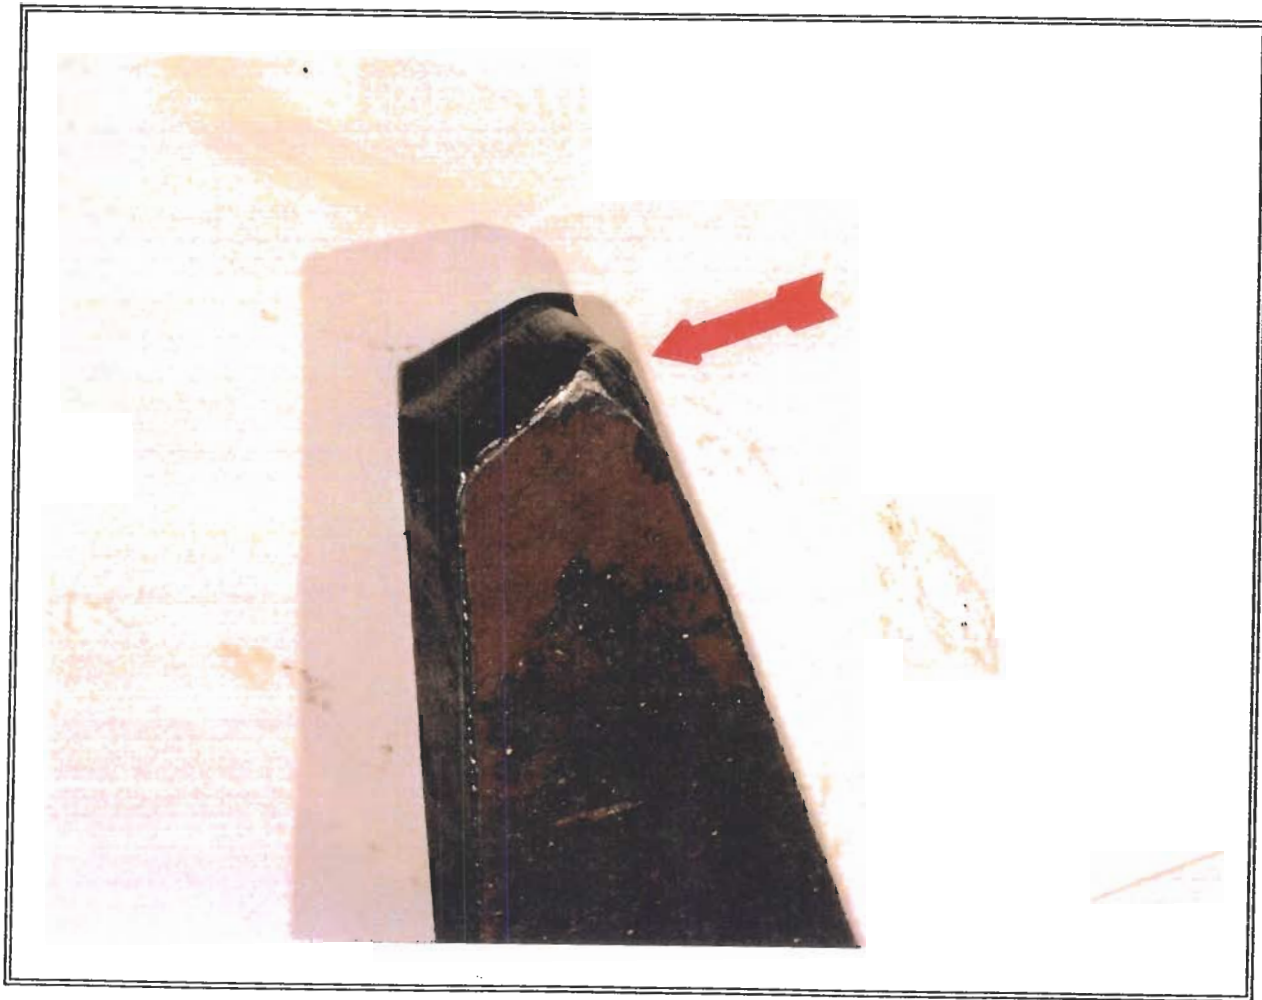
Figure 5.4 Evidence of plastic deformation and wear on the right edge tip of the pawl matches deformation on the edge of teeth - indicative of the two edges wearing against each other.

The results of the second set of calculations indicated that the pawl, with 3 washers on each side, missed the tooth of the engaging flange by .188" due to vacillation of the pawl (ref. Appendix A). It was observed that the edge of the tip of the pawl - on the engaging tooth side - had in fact been plastically deformed by approximately 1/8" reducing the width to 0.875" from 1.0".

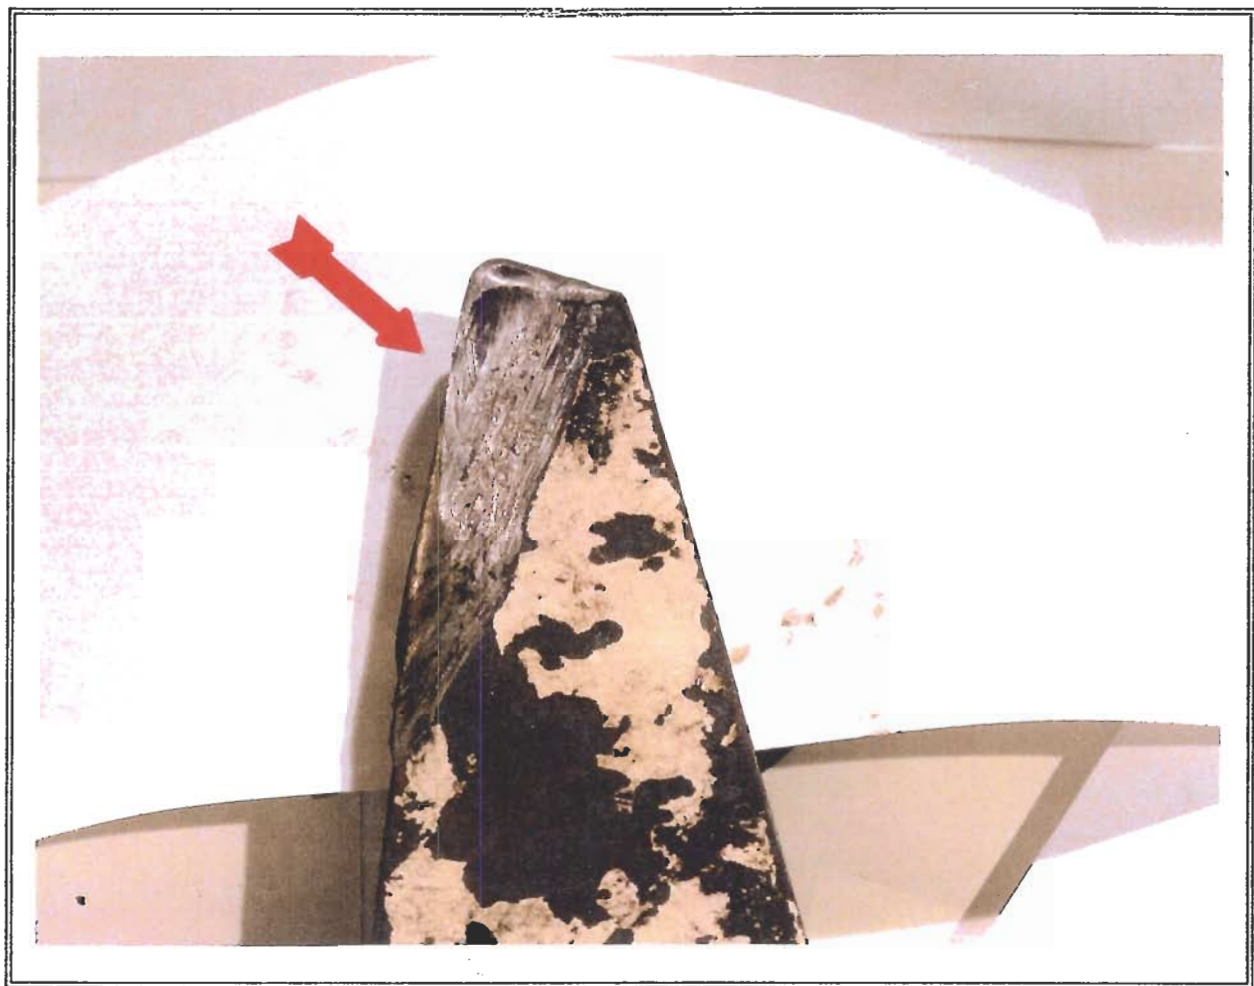
Figure 5.5 Evidence of plastic deformation and significant wear on the left edge of the pawl's tip matches deformation and wear of the brake drum's sheet metal panel.

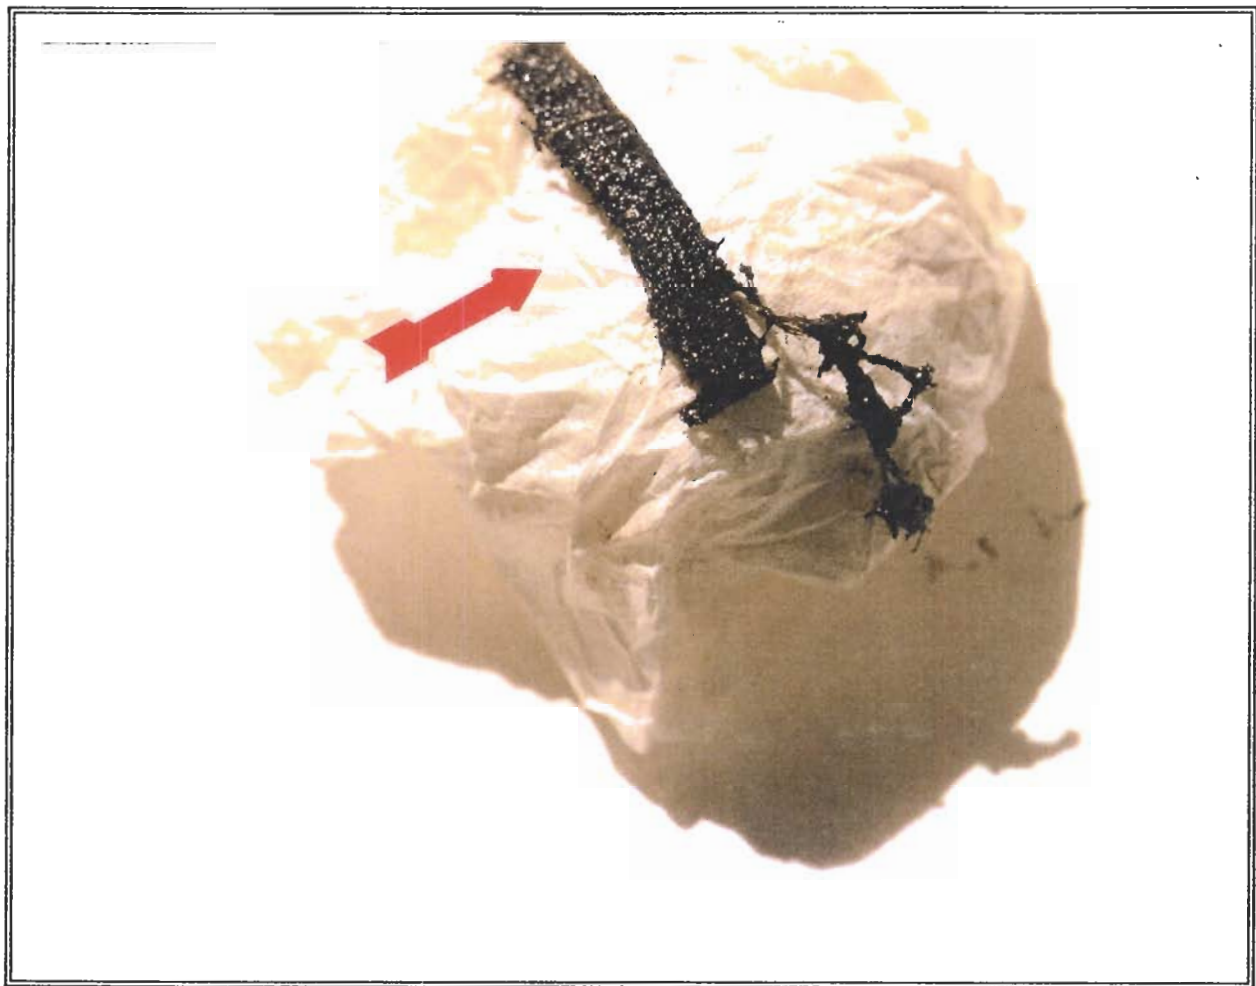
Therefore, when the crane involved in the accident was manufactured in May 1981, it contained both the new fibrous bushing and the nickel-plated bushing. However, OSHA inspection and examination of the fibrous bushing indicated that its disintegrated remains were soaked with a fluid substance. In addition, the inside of the nickel-plated bushing bears identifiable evidence of rust.

Figure 5.6. The fibrous bushing between the pawl and the shaft was found to be significantly disintegrated.

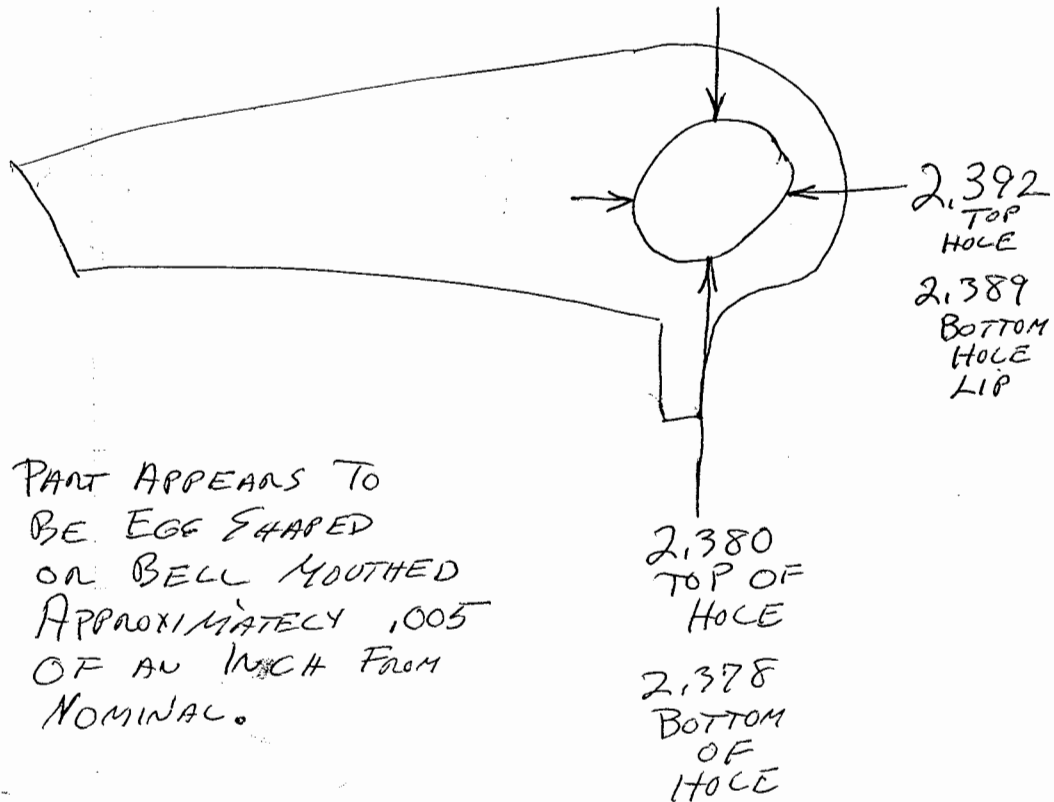
Figure A-1. The inside diameter of the steel bushing of the pawl involved in the accident was measured by OSHA.

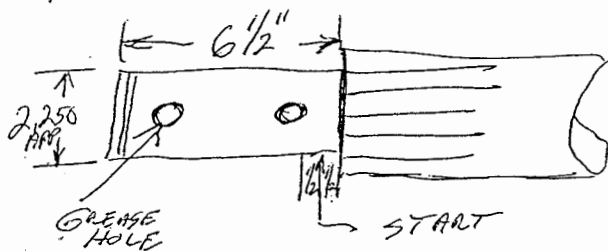
DIAMETER OF THE SHAFT - AS MEASURED BY
OSHA = 2.249" (REF. FIG. A-2).

Figure A-2. The diameter of the shaft involved in the accident was measured by OSHA.

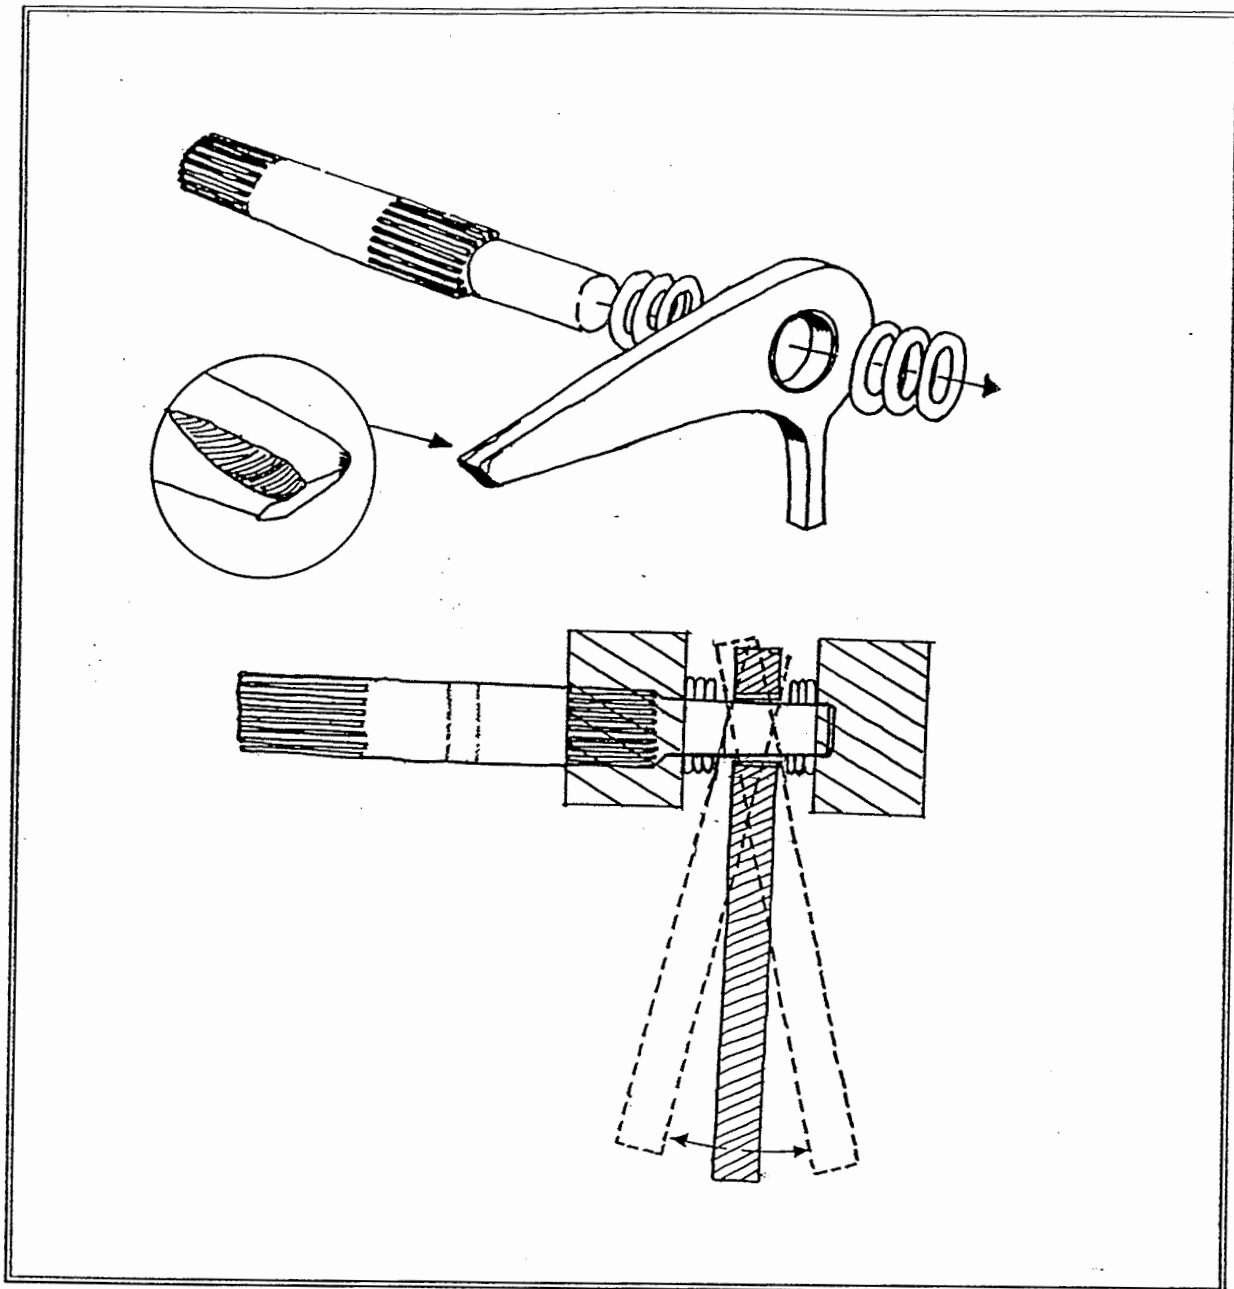
ACCORDING TO THE MANUFACTURER, DEVIATIONS OF
MORE THAN 1.00" - AT THE TIP OF THE PAWL - CAUSE
THE PAWL TO MISS ENGAGING THE TOOTH OF
THE LAGGING (REF. FIG. A-3) $\Rightarrow \Delta_{MIN} = 1.00"$

Figure A-3. The pawl vacillated laterally due to lack of adequate lateral restraint. The existence of adequate lateral restraint (spacer washers) was particularly important since the difference between the radii of the shaft and the steel bushing was significant.

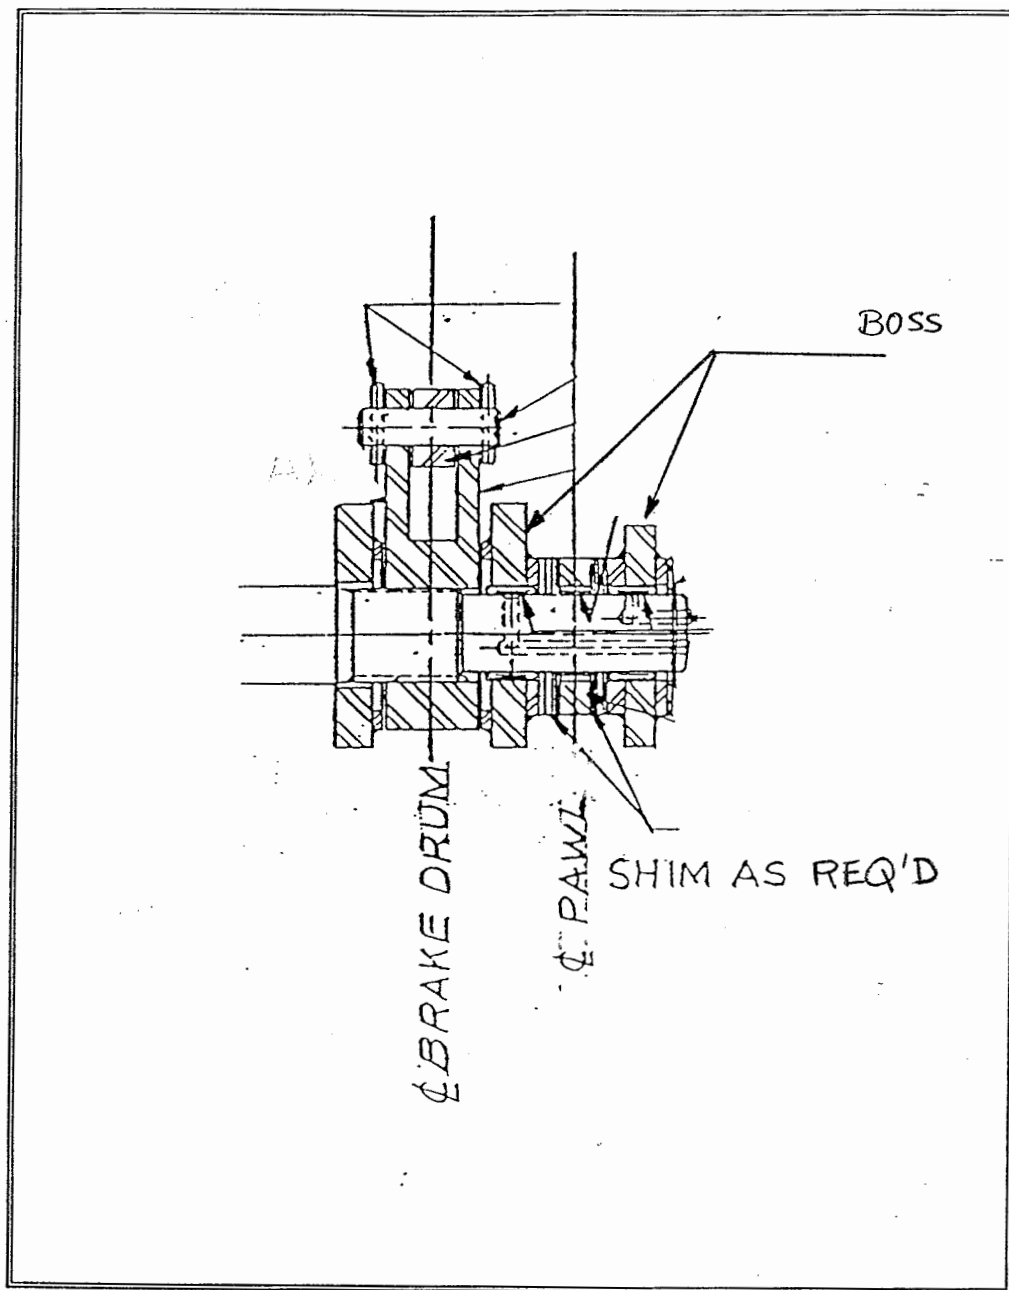
Figure A-4. Three washers installed at each side of the pawl provided the lateral restraint between the pawl and the frame components (bosses).
