INVESTIGATION OF JULY 1, 1992 FAILURE OF A CRAWLER CRANE IN BOSTON, MASSACHUSETTS

U.S. DEPARTMENT OF LABOR
OCCUPATIONAL SAFETY AND HEALTH ADMINISTRATION
December 1992

This report was written
by
David T. Lashgari, P.E.

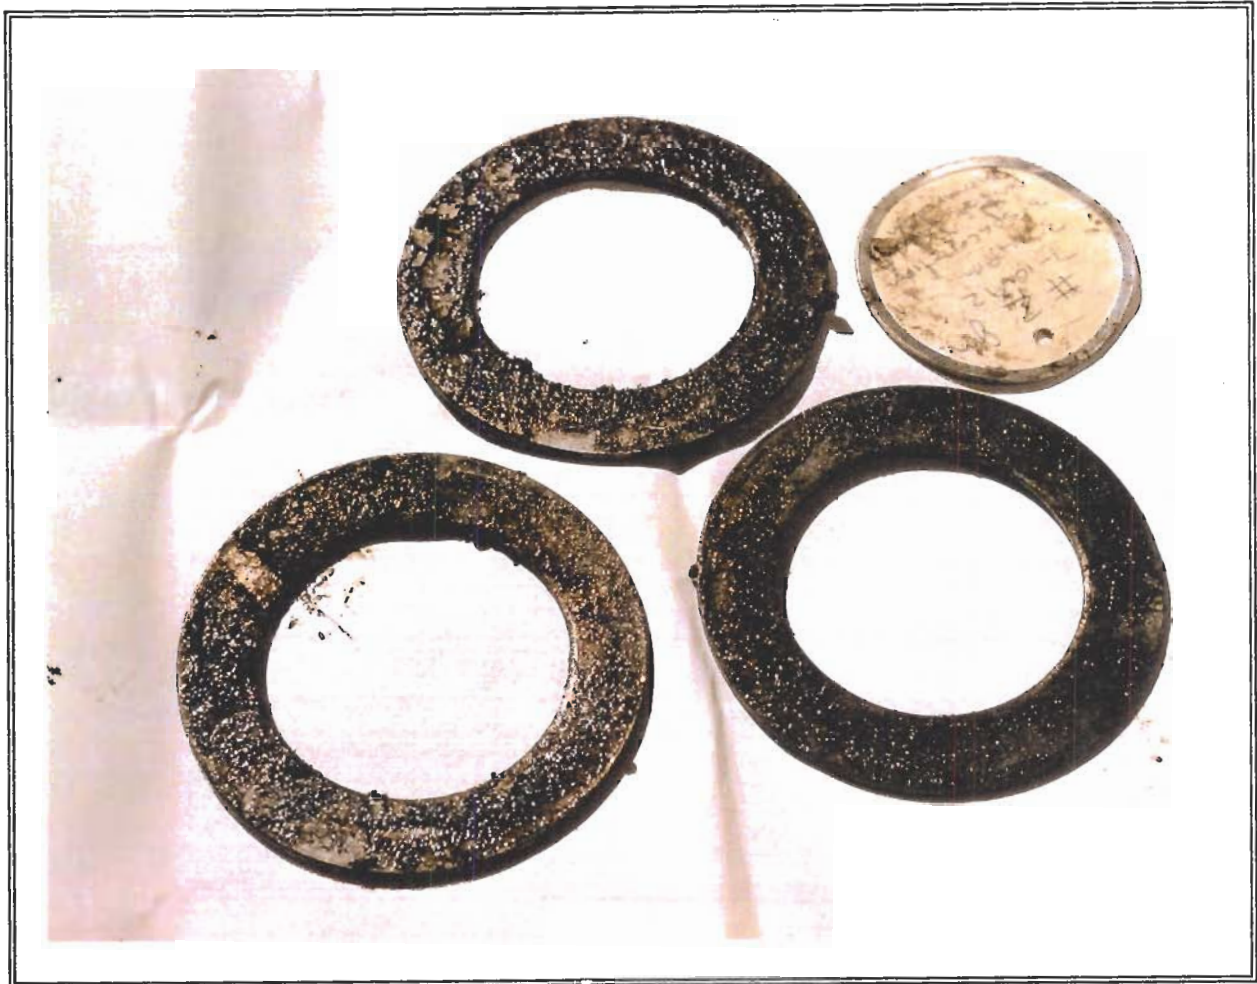
Figure A-5. The space between the pawl and the frame (bosses) were to be shimmed as required by gauge-twelve spacer washers.
