INVESTIGATION OF JULY 1, 1992 FAILURE OF A CRAWLER CRANE IN BOSTON, MASSACHUSETTS

U.S. DEPARTMENT OF LABOR
OCCUPATIONAL SAFETY AND HEALTH ADMINISTRATION
December 1992

This report was written
by
David T. Lashgari, P.E.

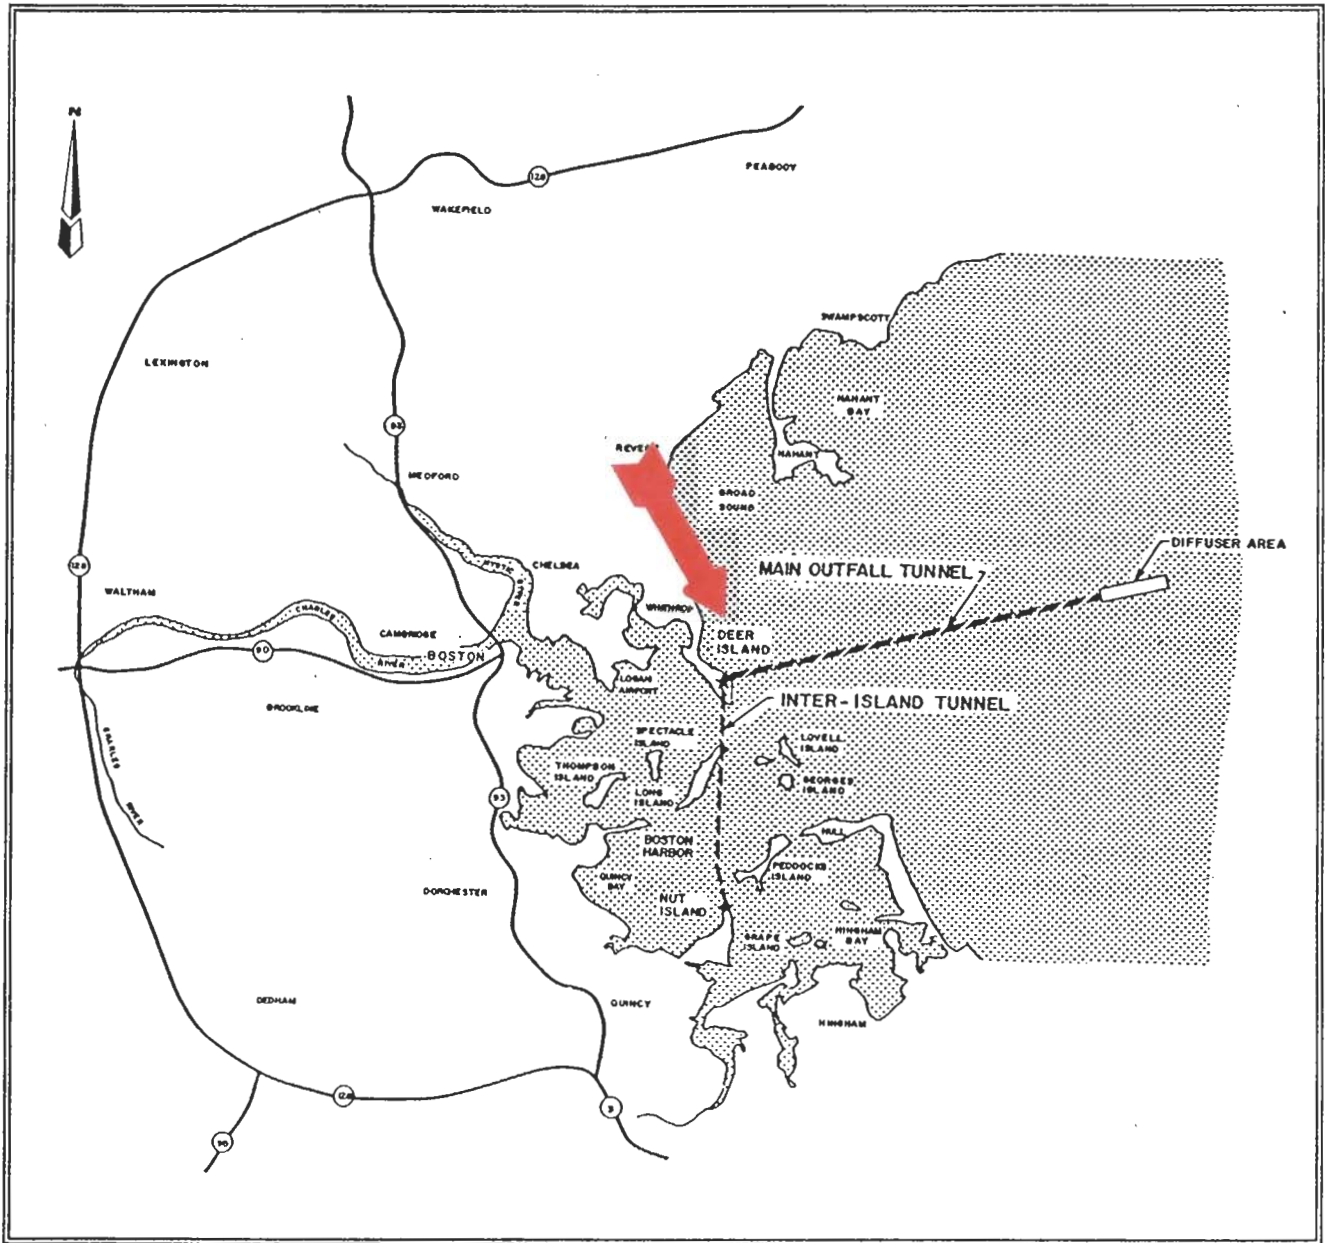
Fig. 1.2 The accident occurred on Deer Island, the construction site of a sewage rehabilitation project - undertaken by the Massachusetts Water Resources Authority (MWRA).

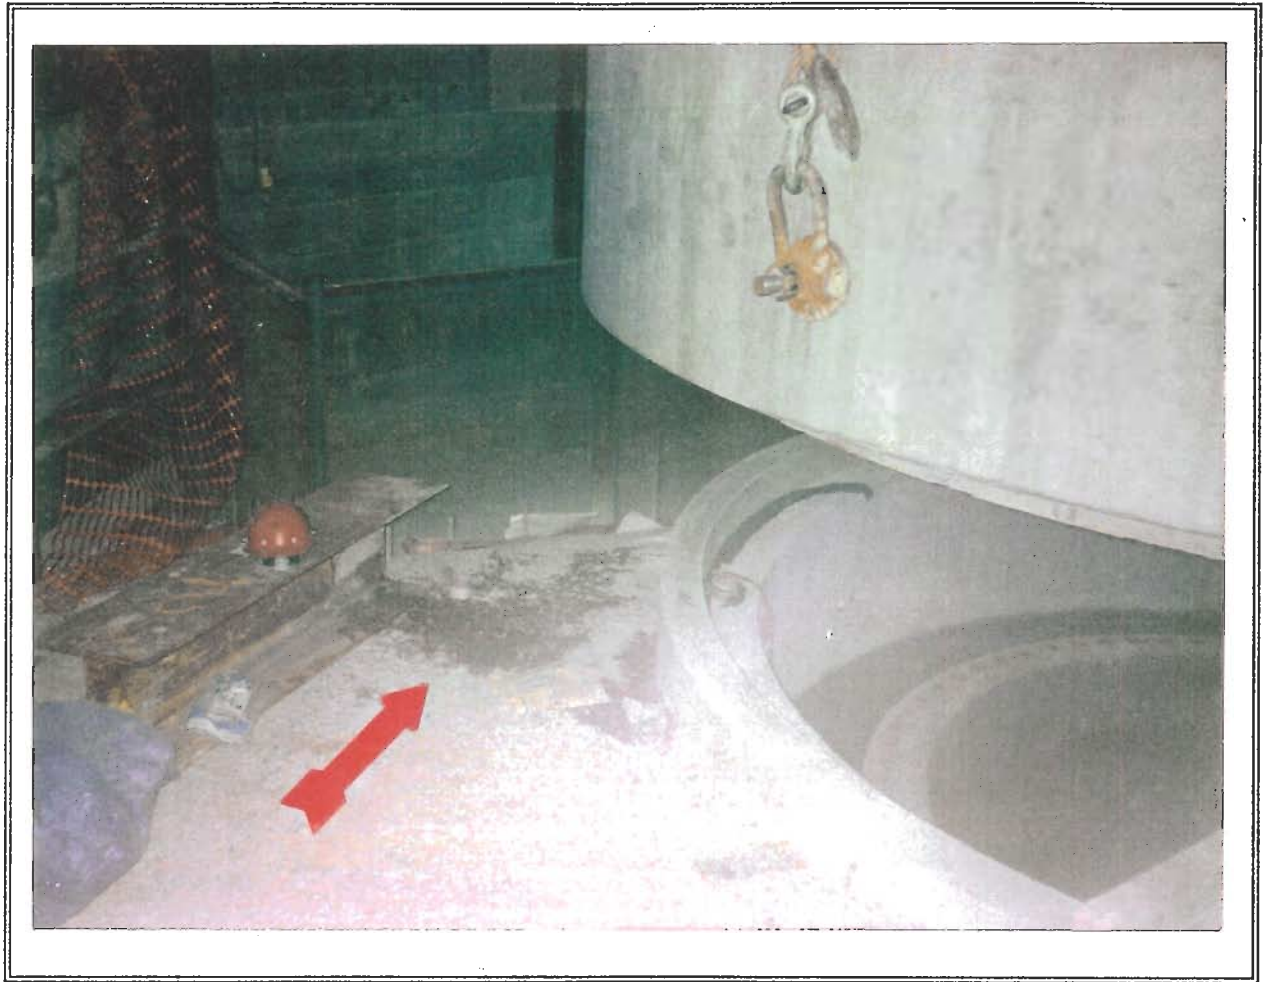
A construction worker (tunnel worker) was fatally injured at about 12:10 p.m. on July 1, 1992, when a 13-ton cylindrical precast concrete section fell on him. The concrete section had been lifted by a 500,000-pound-capacity crawler crane and was held at about four feet above the victim and three other workers when it suddenly released and fell and struck the victim (ref. fig. 1.1). During this operation, the main hoist drum of the crane was used with single part line over the main boom. According to the manufacturer, the lifting capacity of the crane for this configuration was 46,000 pounds. The accident occurred on Deer Island, Boston, Massachusetts, the site of a sewage rehabilitation construction project, undertaken by the Massachusetts Water Resources Authority (MWRA) (ref. fig. 1.2). Immediately prior to the sudden fall of the concrete section, three tunnel workers and an independent truck driver were applying a sealant material to a newly installed manhole section to which the fallen concrete section was to be connected (ref. fig. 1.3).

Figure 1.3 The four workers were applying a sealant material at the connection of the concrete sections.

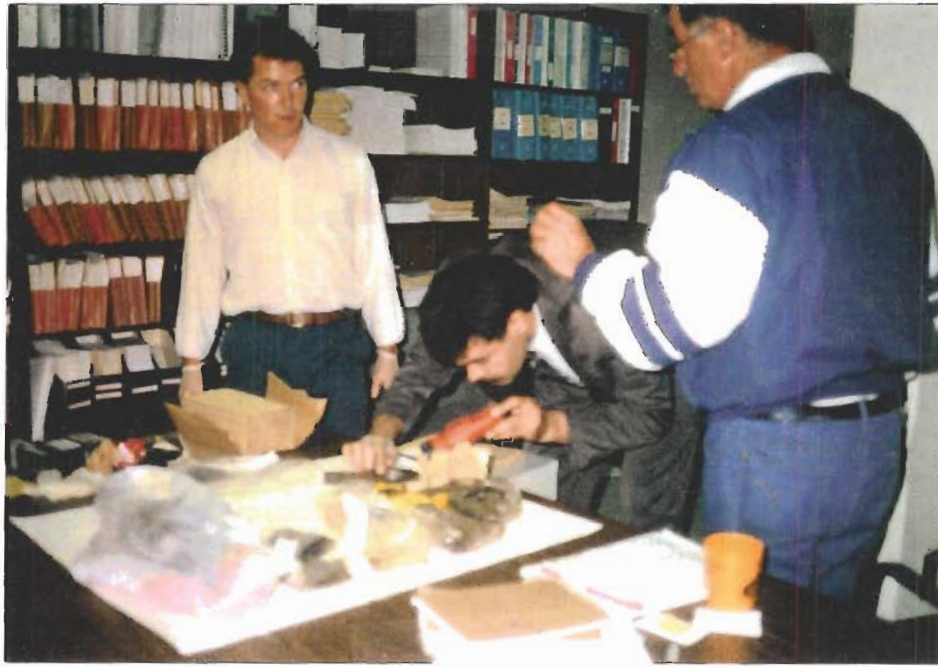
Figure 1.4 Members of the OSHA investigative team examining collected evidence.

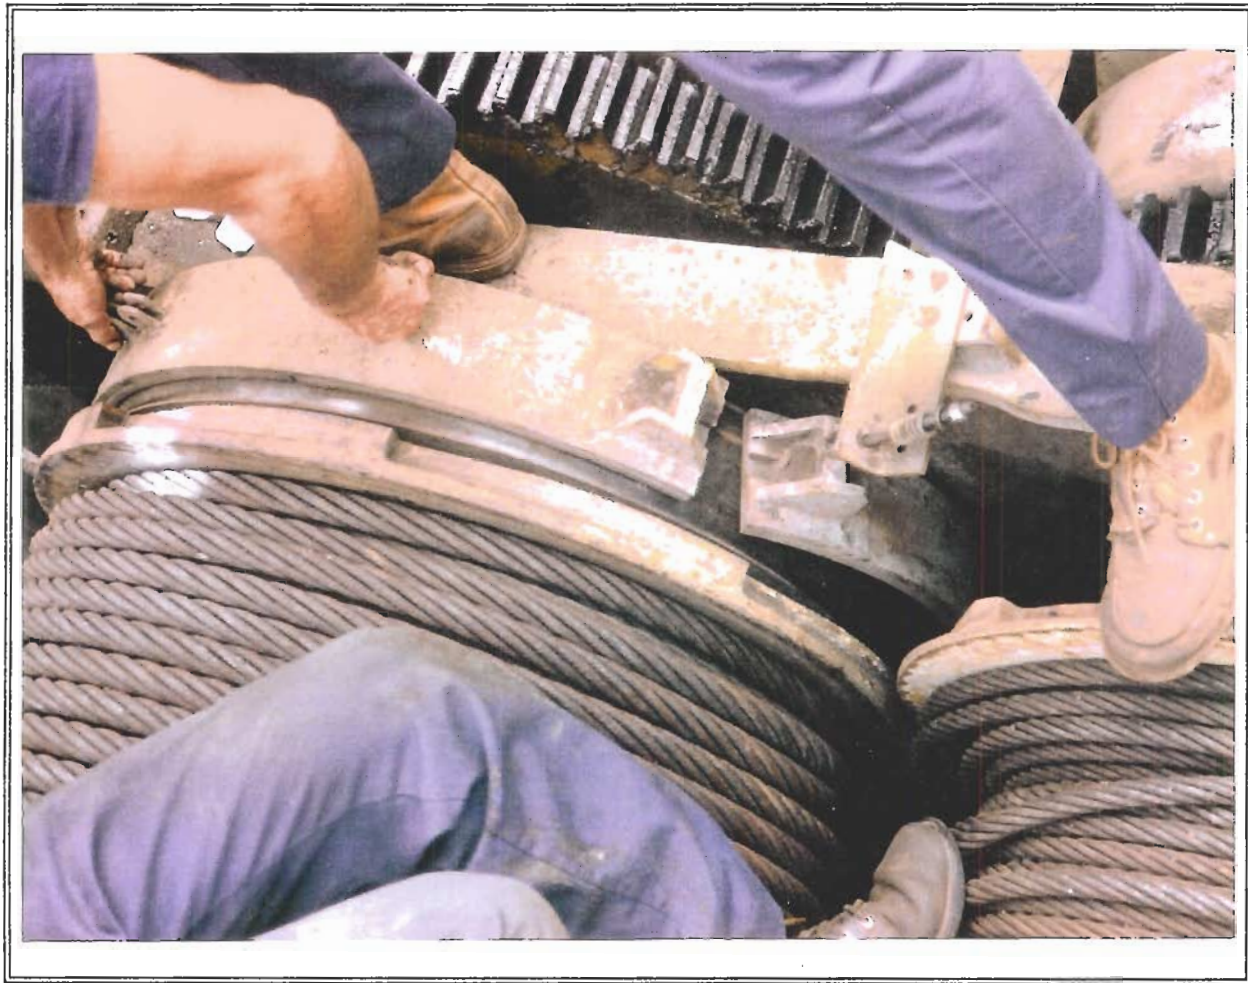
between the brake drums and the brake linings were removed. Disassembly of the friction brake bands and linings indicated the existence of rust patches on the surfaces of both brake drums. In addition, a significant quantity of rust, scale and other foreign particulate matter was collected by OSHA from the interior surfaces of the disassembled brake linings.

request of OCE. Further inspection, examination, and interviews were conducted on August 3, 4 and 6, 1992 (ref. fig. 1.5).

Figure 1.5 Under OSHA supervision, the friction brake system of the crane's main hoist drum was disassembled for further investigation.

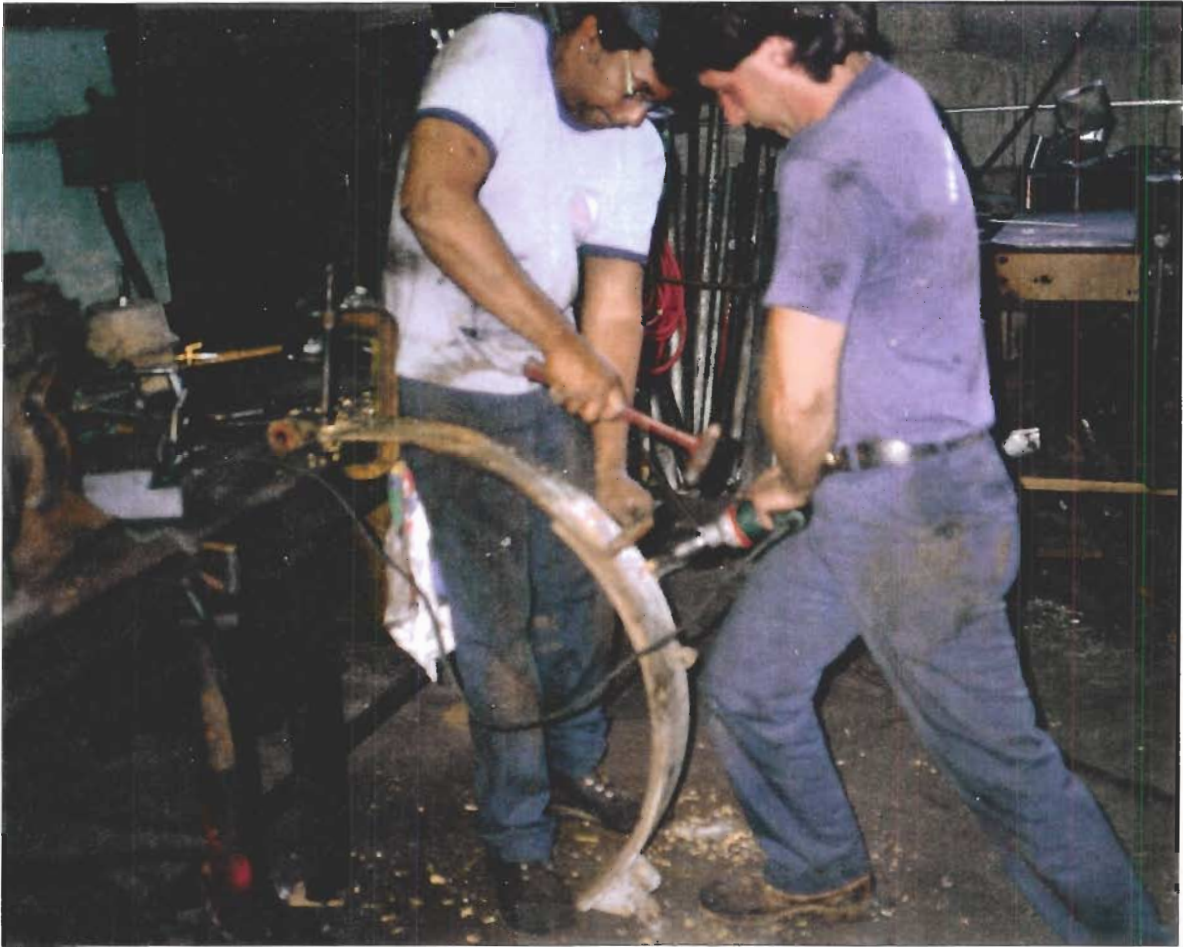
The OSHA investigation involved eyewitness accounts, interviews of the crane operator, examination and inspection of the crane and its various components, conducting tests on various mechanical systems of the crane, review of the original design drawings of the crane, and interviewing the engineering staff of the crane manufacturer. In addition, as further investigation focused the concentration of the investigative process toward the braking mechanism of the crane, arrangements were made for disassembly of the crane's braking system to further inspect and examine the internal components of the system (ref. fig. 1.6).

Figure 1.6 Disassembling of the friction brake system of the crane's main hoist drum.

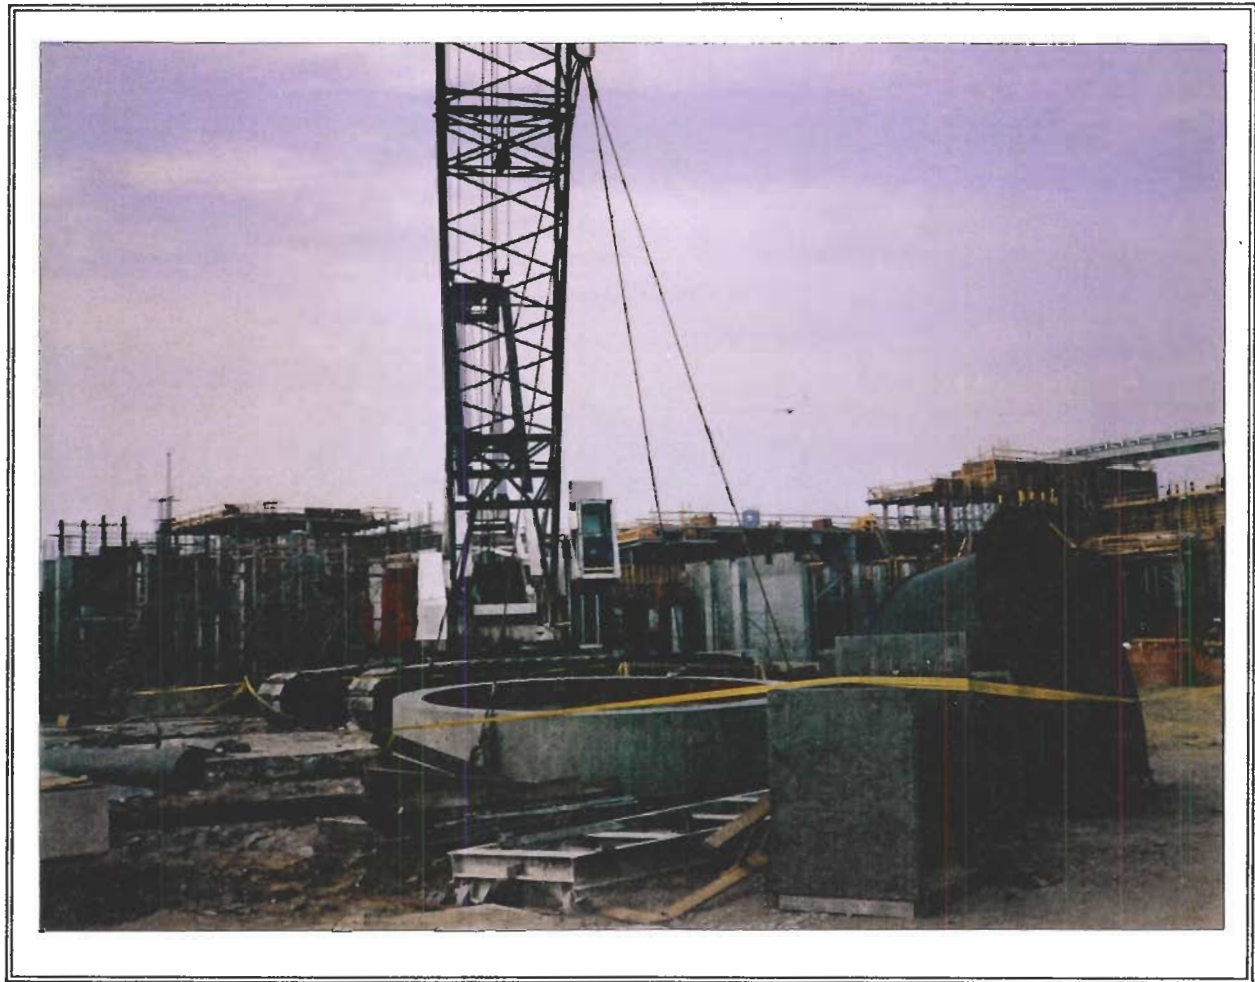
the load line was secured to the four connection lugs (ref. fig. 3.1). The load was held at about four feet above the bottom concrete section and three tunnel workers and an independent truck driver proceeded to apply the sealant material to the rim of the bottom concrete section by getting underneath the suspended concrete section. One of the tunnel workers was situated inside of the bottom concrete section while the other three applied the sealant material from positions in the outer perimeter of the concrete section (ref. fig. 3.2).

Figure 3.1 The 14-foot diameter cylindrical concrete section was lifted by the crane after the load line was attached to the four connection lugs.

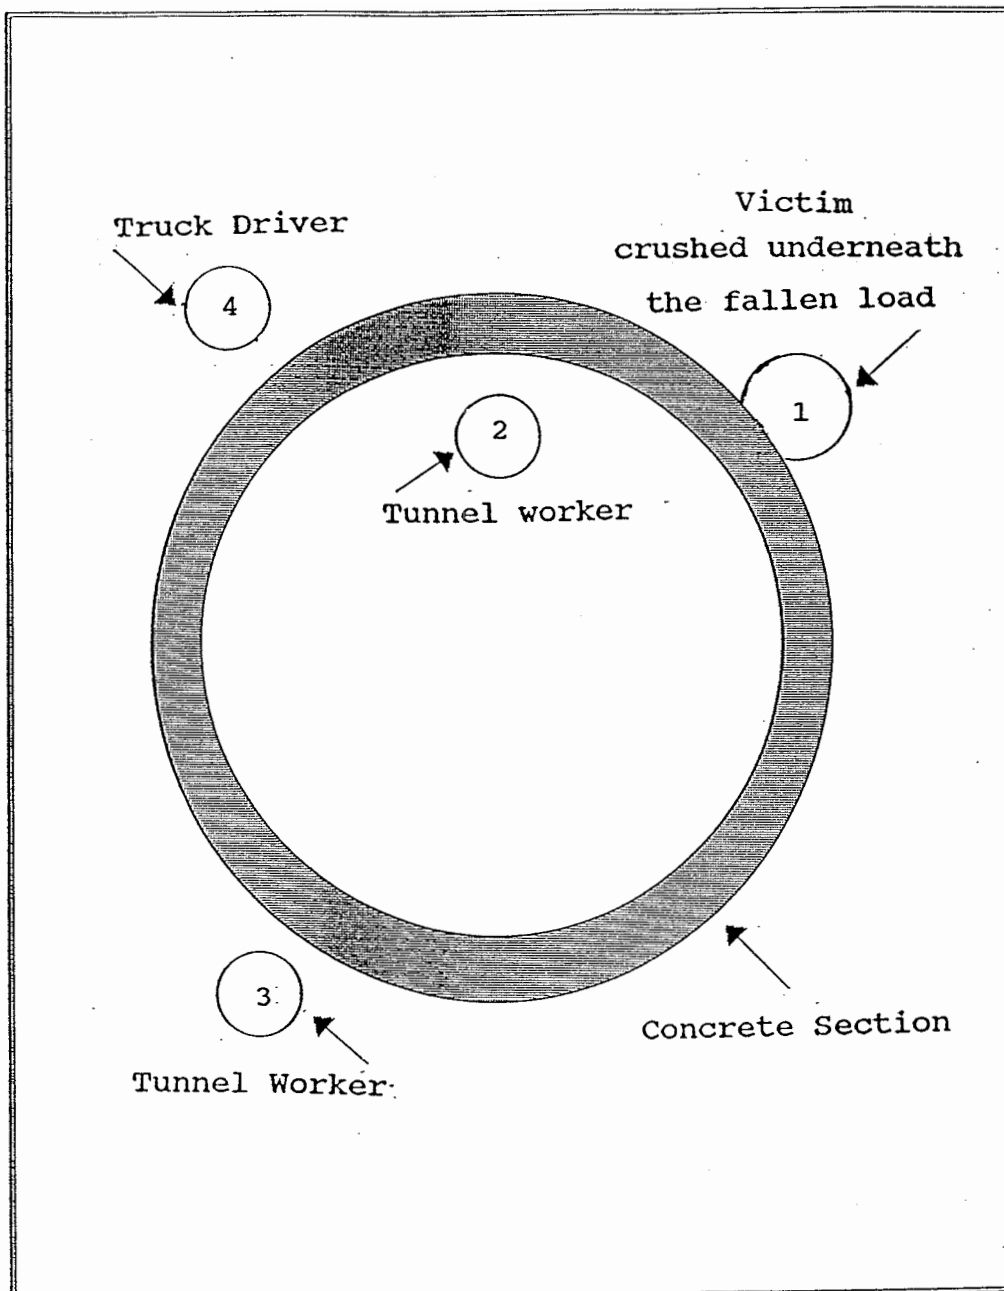
Figure 3.2 The topview of the accident scene immediately prior to the release and fall of the concrete section.

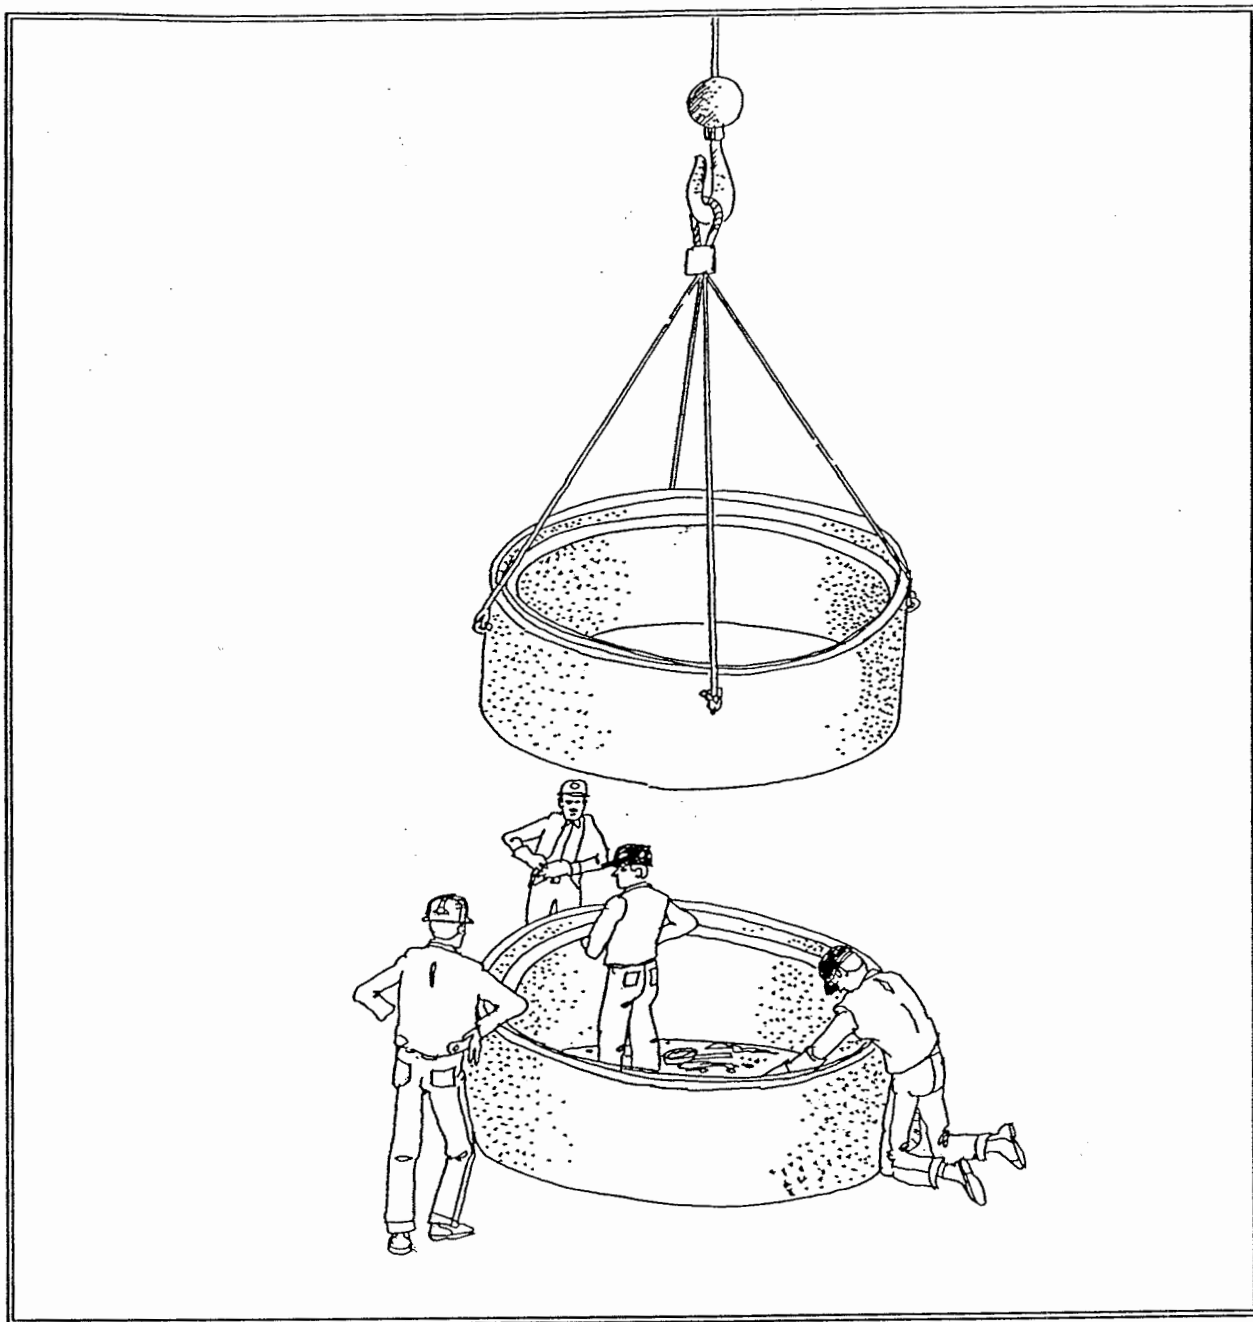
According to eyewitness statements, the operator had locked the primary brakes by having pressed and locked the latch attached to the foot brake pedal (ref. fig. 3.3). Then, the operator proceeded to activate the (secondary) spring-applied, hydraulically-released brake system. In order to engage the secondary brake system - consisting of a pawl engaging the sloping teeth of the front drum - the operator slightly released the friction brake so the tip of the pawl could position itself on the teeth of the front drum (ref. fig. 3.4). Once having assumed that he had engaged the secondary mechanical brake, the operator proceeded to lock the friction brake by pressing his foot on the pedal. It is at this instant that according to eyewitness statements, the load slid through and struck the victim (ref. fig. 3.5). However, moments prior to the sudden fall of the load, three of the workers had finished application of the sealant material and had stood upright while the victim was still in the kneeling position - engaged in application of the sealant material to the surface of the bottom concrete section (ref. fig. 3.6). The falling section struck the victim and caused him fatal injuries.

Figure 3.6 Three of the workers were in the process of applying the sealant material and stood upright. The victim was still in the kneeling position.

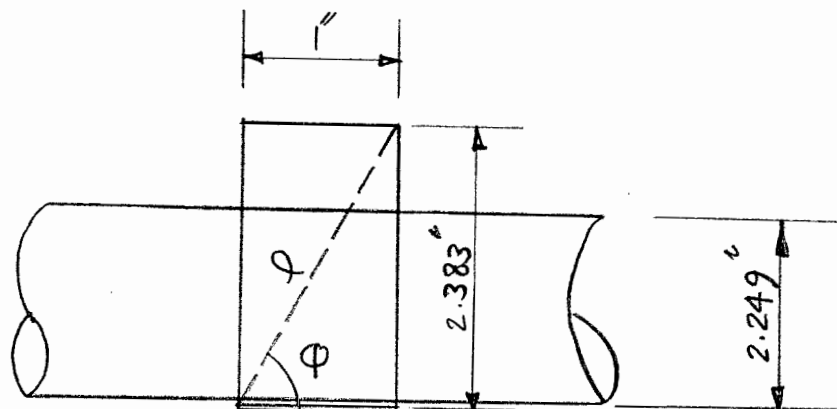
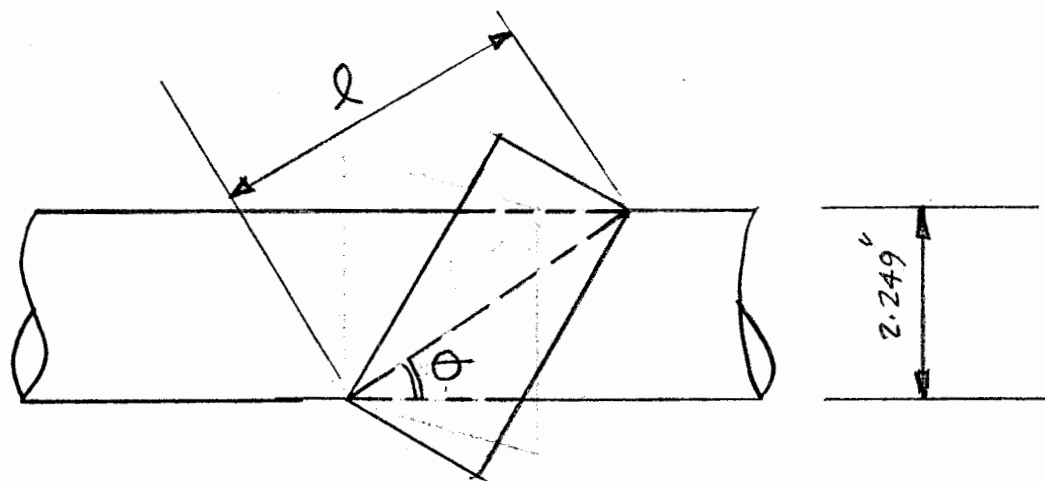
DIAMETER OF THE SHAFT - AS MEASURED BY
OSHA = 2.249" (REF. FIG. A-2).

DIFFERENCE OF RADII OF PAWL AND SHAFT = 0.134"

SHAFT & STEEL BUSHING
(BEFORE TIPPING)

SHAFT & STEEL BUSHING
(AFTER TIPPING)

Δ = MAXIMUM LATERAL DEVIATION OF THE PAWL'S TIP
BASED ON EFFECT OF RADI DIFFERENCES.

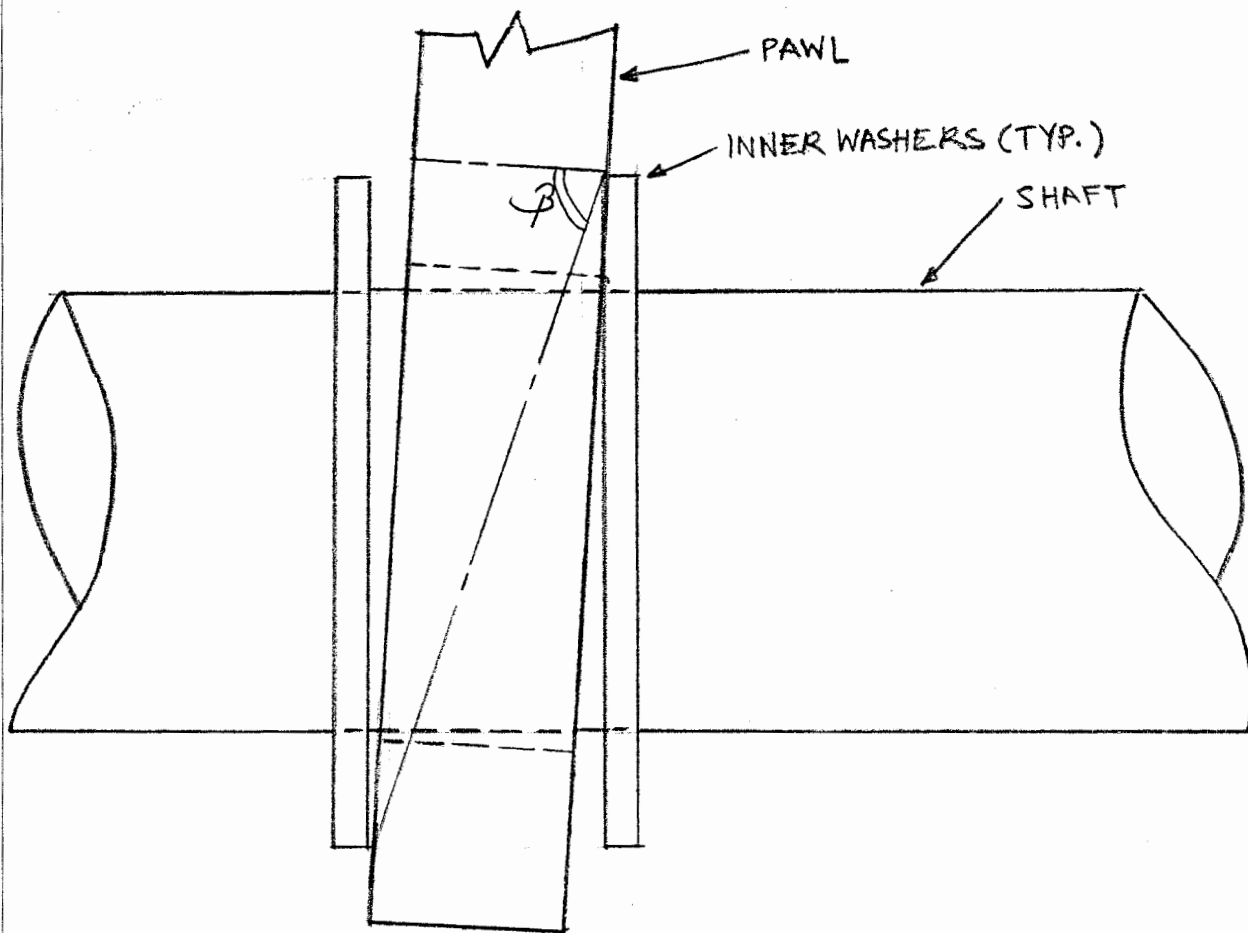
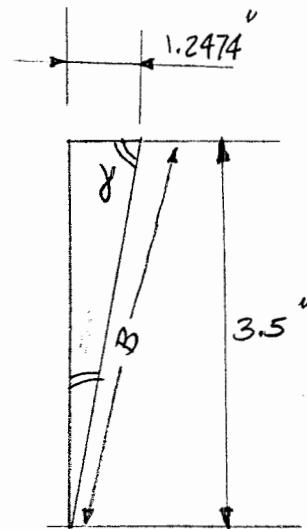
ACCORDING TO THE MANUFACTURER, DEVIATIONS OF
MORE THAN 1.00" - AT THE TIP OF THE PAWL - CAUSE
THE PAWL TO MISS ENGAGING THE TOOTH OF
THE LAGGING (REF. FIG. A-3) $\Rightarrow \Delta_{MIN} = 1.00"$

$$\begin{aligned} \text{TOTAL VACILLATION AT TIP} &= (\sin \phi_2)(12.19'') \\ &= 0.851'' \end{aligned}$$

THUS, COMPARISON OF RESULTS OF CASES 1 & 2
INDICATES THAT THE PAWL'S TIP DEVIATION IS
CONTROLLED BY CASE 2.
